Contra Costa Community College District

Applied Arts Building

HVAC and Controls Evaluation

March 29, 2019

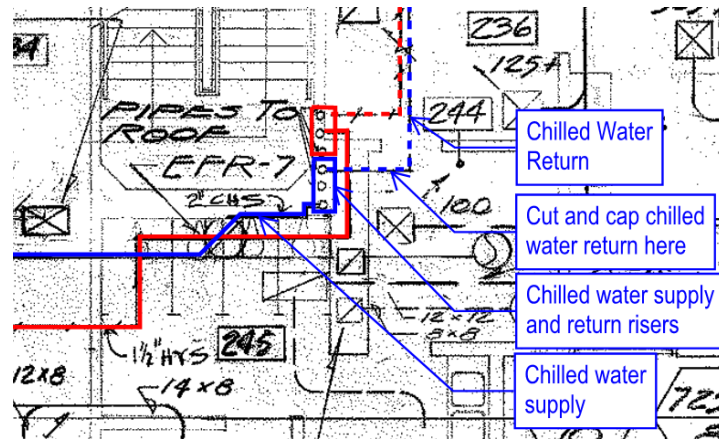
Figure 1. Chilled Water and Hot Water Risers at Second Floor

2. Drain and Abandon Chilled Water Distribution and Coils on Second Floor

We recommend that the chilled water piping distribution and coils on the second floor be drained and abandoned in place to avoid the high first cost and control complexity associated with conversion to DDC. We see two options for draining the system. The first option is to drain the entire chilled water system using the existing drain on the chilled water return line in Room 117F.1 (the room where the VFDs for the chilled water pumps are located), cut and cap the chilled water return line where it connects to the riser on the second floor, see Figure 1, and decommission the dedicated second floor chilled water pump. The chilled water system would then need to be re-filled and water treatment chemicals reapplied. The second option is to hot tap a drain into the dedicated chilled water supply pipe for the second floor coils at a low point in the system, freeze or line-stop the chilled water return line in the same location where indicated to cut and cap in Figure 1, drain that portion, then cut and cap the chilled water return line where indicated in Figure 1 and decommission the dedicated second floor chilled water pump same as the first option. The second option avoids having to drain, refill and re-apply chemicals to the entire chilled water system.

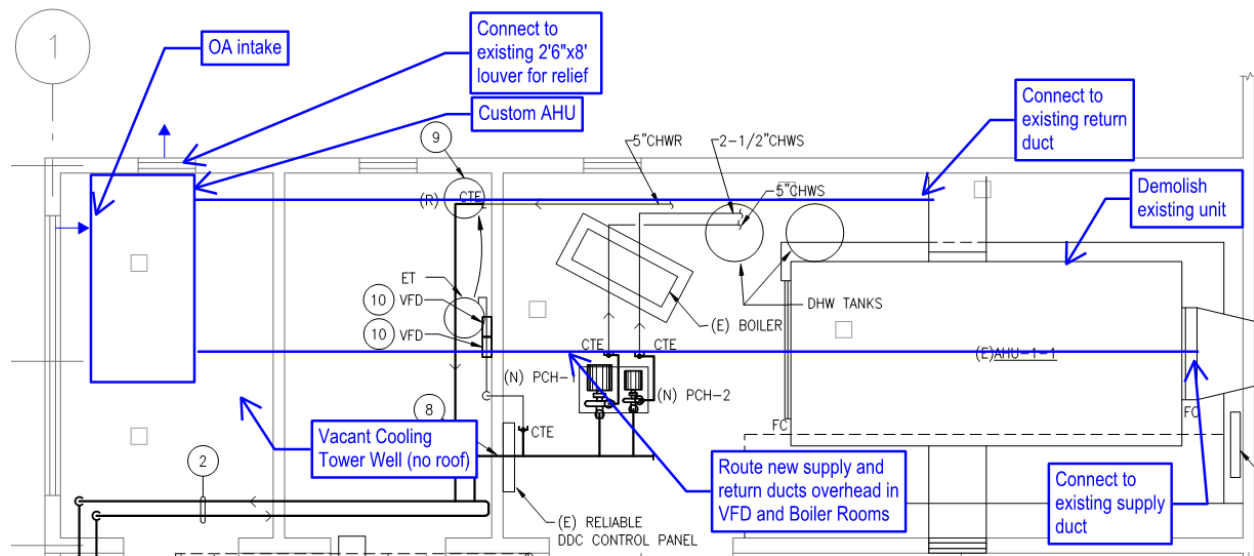
Figure 2. Schematic of Option 1: Install a New Unit in Vacant Cooling Tower Well

The matrix below compares the options by weighting the importance of each attribute and providing a ranking of each option on a scale from 0 (low) to 10 (high) with respect to each attribute. The products of the attribute weight times the rank for each attribute are summed and compared by option. The higher the total score, the better the option. Figure 2 shows a schematic of Option 1.

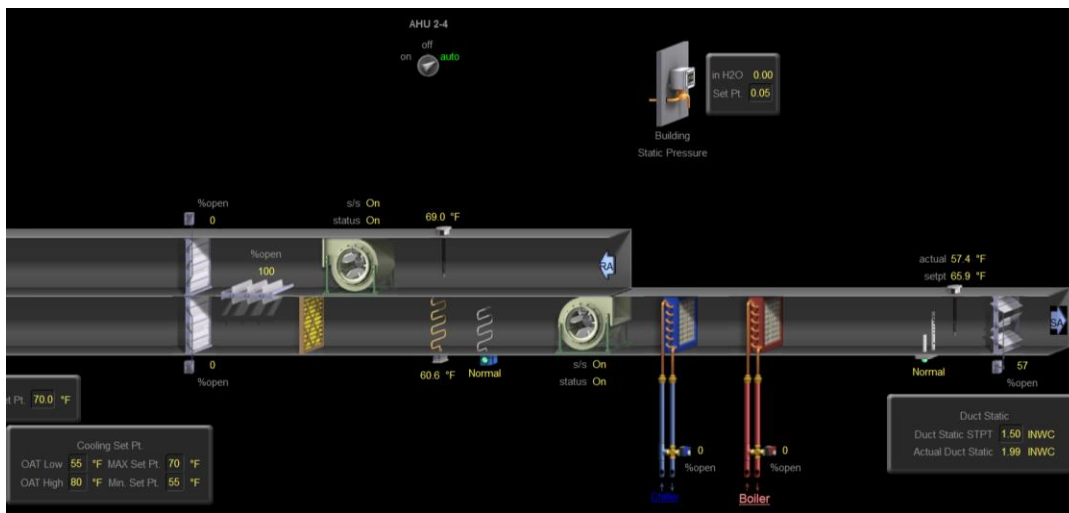
- AHU 2-2
 - Return fan recirculating on itself due to the return fan discharge damper being mostly shut with bypass door between the return and return fan discharge plenum fully open
 - Building pressure slightly negative at -0.039"
 - Duct static pressure high at 2.32"
- AHU 2-3
 - Outside air being pulled in through relief path due to return fan discharge damper being mostly shut
 - Incorrect exhaust air damper operation: it closes when OA damper opens

Figure 3. AHU 2-4 ALC Graphic

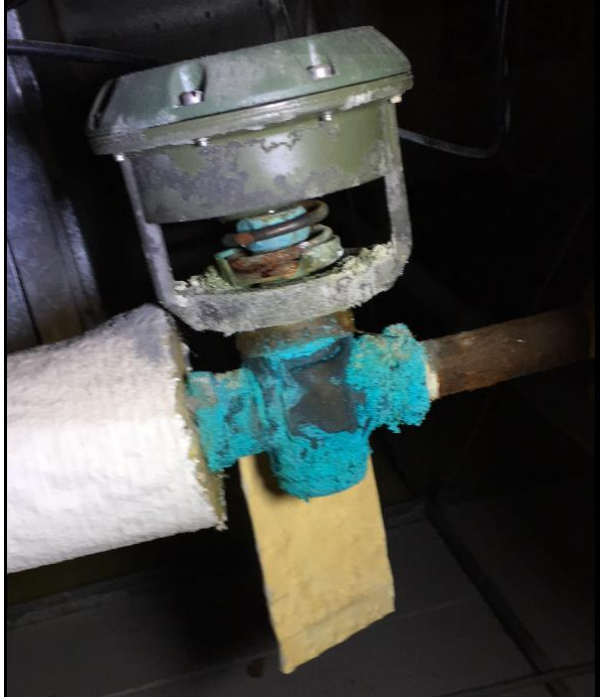
The interior piping we observed at terminal units was still in good condition. Insulation was intact with limited signs of wear. Reheat valves did however show signs of minor leakage in the form of rust; see Figure 4.

Figure 4. Pneumatic Hot Water Valve

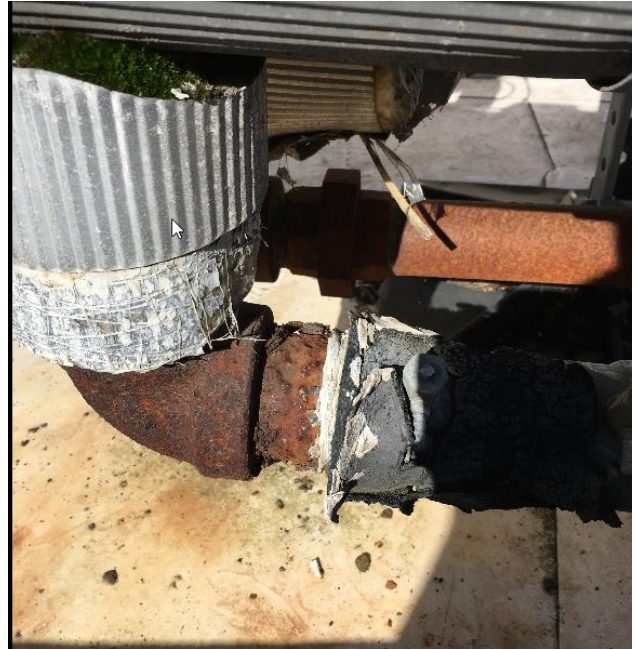
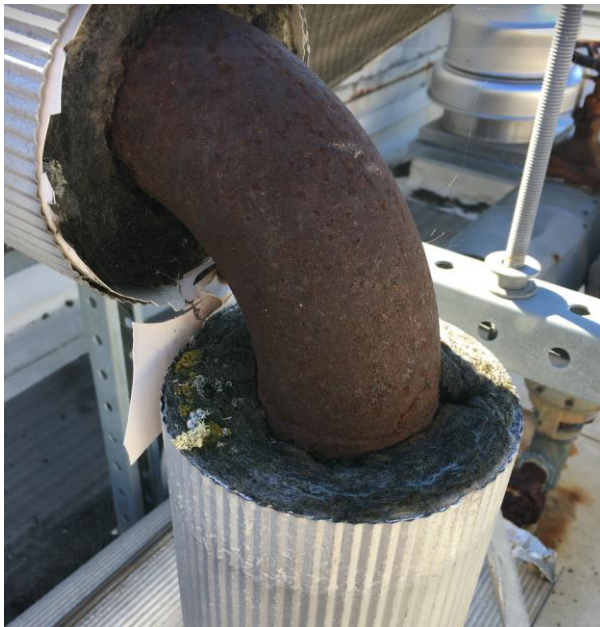
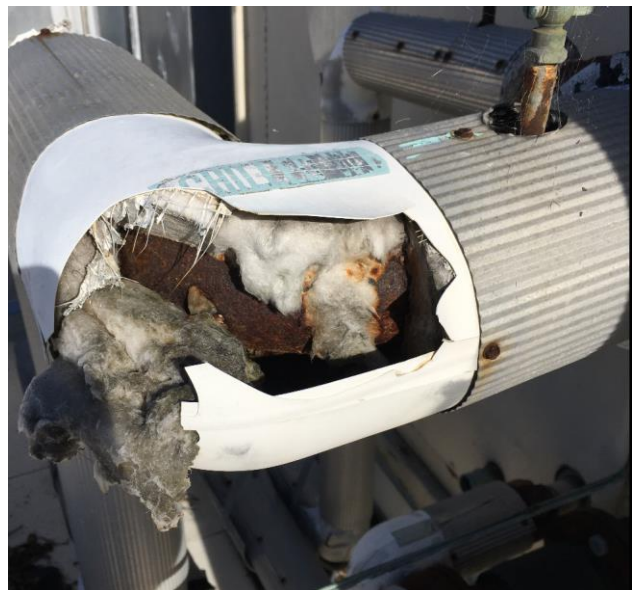
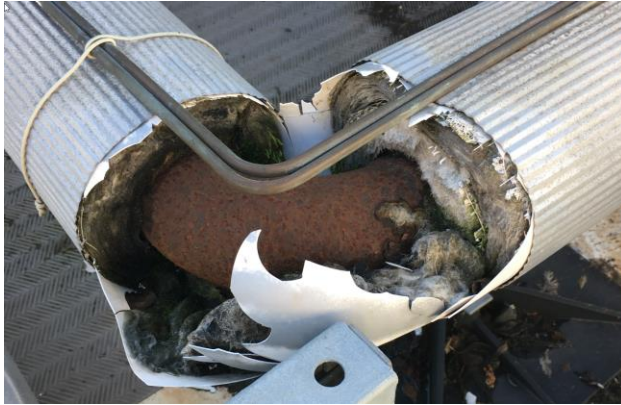
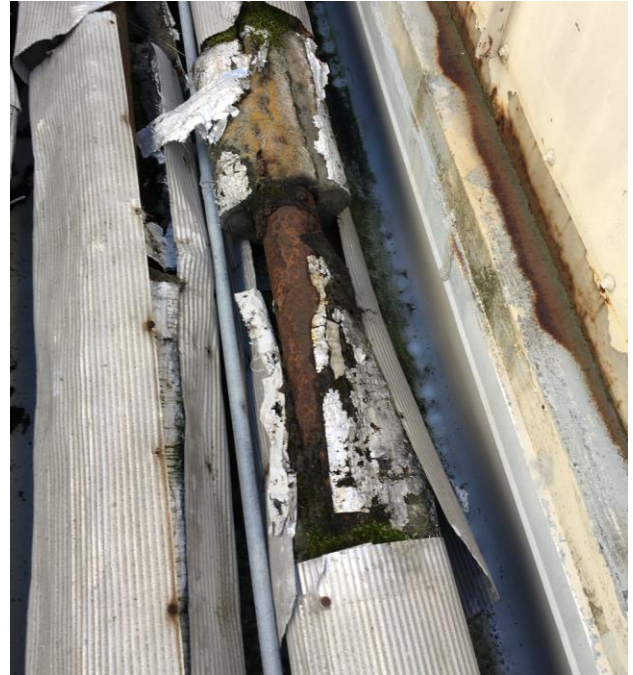
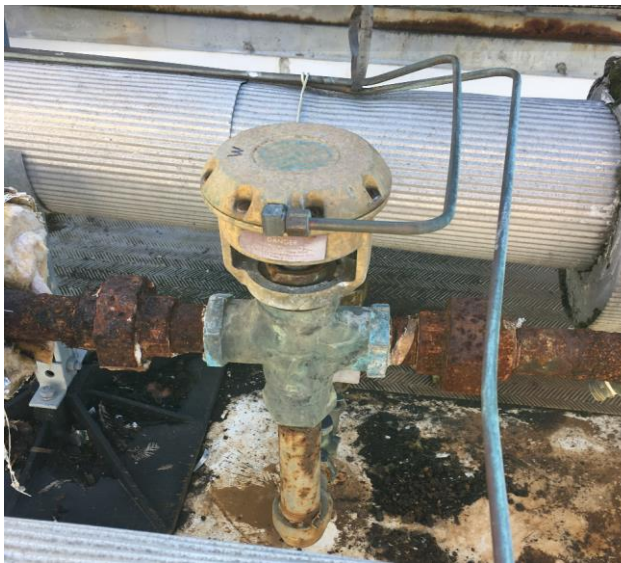
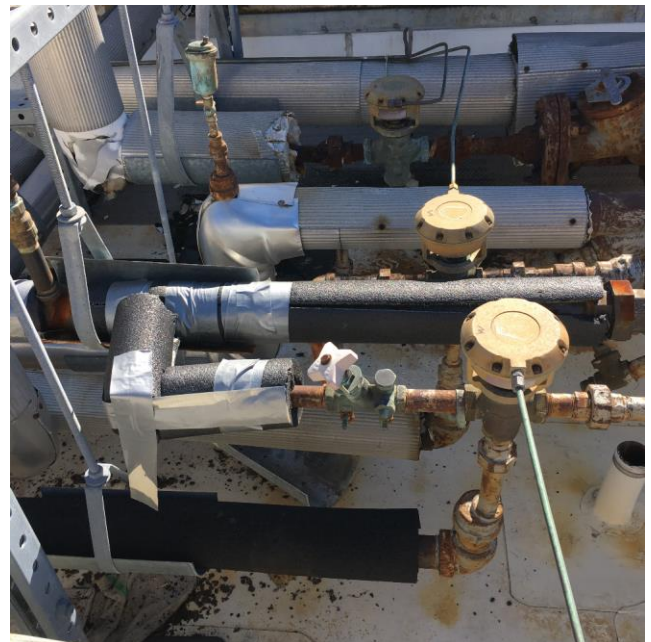
The rooftop chilled water and hot water piping was installed in 1979. As observed during our site visit, both the weather jacket covering the piping insulation and the piping insulation itself have failed. The jackets and the fiberglass piping insulation are tattered and missing throughout and the piping insulation was wet throughout, which means that it has permanently lost almost all its insulation value. The exposed piping is very rusted and corroded, see photos in Appendix A. Building staff did not report any leaks but is likely that leaks will become regular and require more frequent maintenance as the piping continues to corrode.

Replacing the rooftop piping should be the first priority. The extreme corrosion observed on all of the hot and chilled water pipes predisposes the distribution systems to a catastrophic leak. Additionally, the tattered state of the pipe insulation results in substantial energy waste.

Figure 6. Rooftop Piping

Figure 5. Rooftop Piping

Figure 7. Rooftop Piping

Figure 8. Rooftop Piping

Figure 10. Rooftop Piping

Figure 9. Rooftop Piping

Figure 11. Rooftop Piping

1. Replace Rooftop Chilled Water and Hot Water Piping

All of the chilled water and hot water piping and pipe insulation on the roof needs to be replaced. Replacing the piping will prevent the added water and energy waste and maintenance costs associated with future leaks.

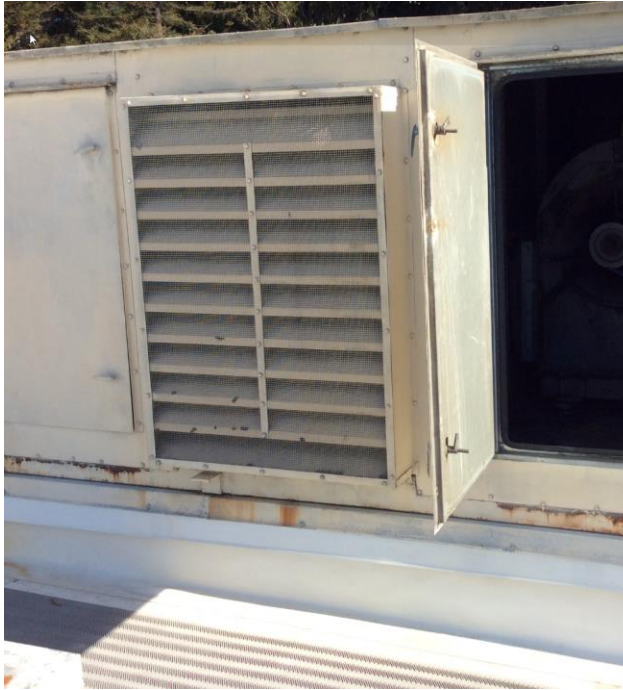
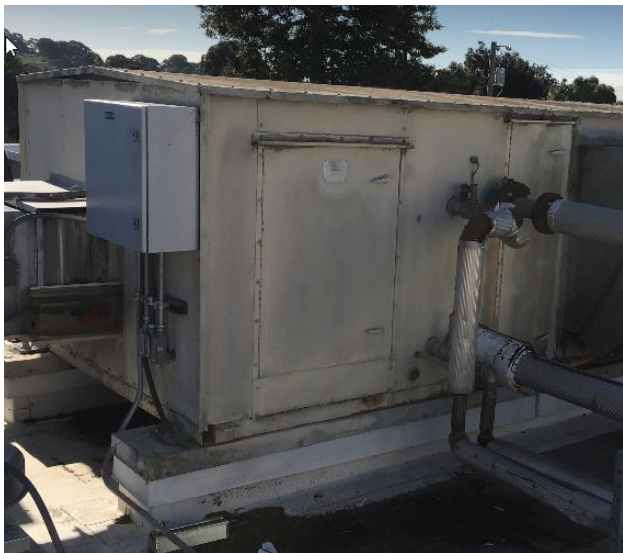
- Overall the unit casing is in acceptable condition, but we believe that the housings are not very air tight.
- Supply and Return Fans
 - Several of the fans were making very loud humming/whining noises during our site visit, especially the supply fan for AH 1-2.

Figure 12. AHU 1-2

Figure 13. AH 1-2

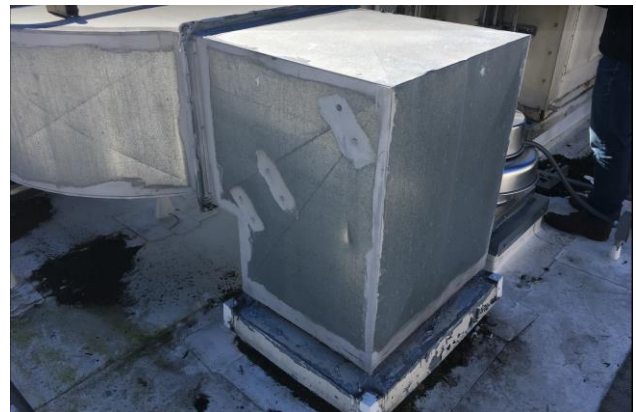
The rooftop ductwork is in good condition with minimal signs of rust, but we did witness puddles on top of several segments of ductwork. Consider installing sheet metal covers at a slight angle over the ductwork to shed water and prevent future rust and corrosion.

Figure 15. Rooftop Ductwork

3. Install Sheet Metal Covers on Rooftop Ductwork

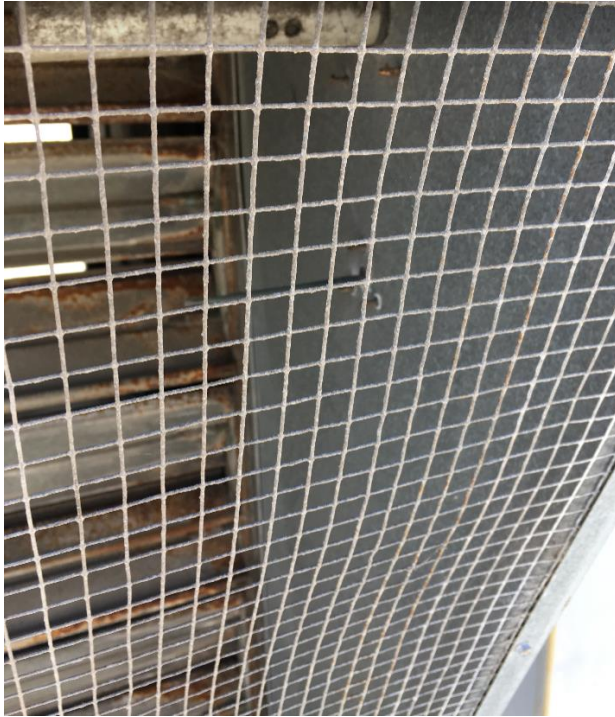
- Most of the outdoor air dampers and relief dampers had a significant amount of rust on the blades and linkages.
 - When tested, roughly 10 to 20% of dampers failed to move either due to bound linkages or failed actuators.
 - The dampers are past their expected service life of 20 years.
- Ductwork
 - Several sections of rectangular rooftop ductwork had some standing water on top, indicating that the ductwork was not installed at a slight slant, which is best practice for preventing rust and corrosion.
 - The ductwork is in good condition with very little visible rust.
- Noise
 - Facility staff noted frequent rumbling noises above rooms 137 and 140, both served by induction VAV units with DDC controls installed in 2018 and both served by AHU 1-2, the unit that we observed making a loud whining noise.

Figure 16 AHU 1-2 Outdoor Air Damper
