SITE VISIT REPORT No. 3 | September 30, 2021

Diablo Valley College Gymnasium Roof Assessment

Observation and Assessment of Existing Roofing Assemblies at Gymnasium

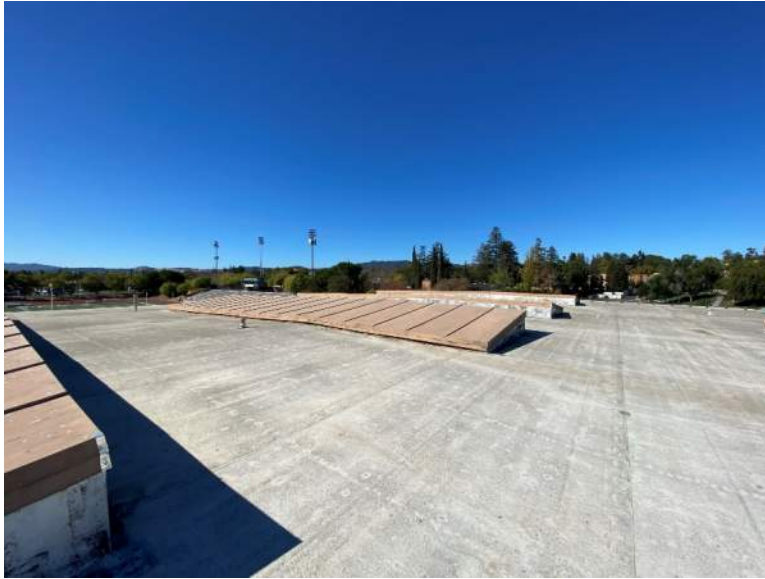
The main roof at the gymnasium is made up of a Sarnafil PVC, single-ply membrane (PVC membrane), which is mechanically fastened to the deck sheathing with heat welded at seams between the PVC membrane sheets (Figure 2). Numerous roof patches and core locations have been repaired with either welded PVC membrane patches or a liquid-applied sealant, all of which appear to be in fair but serviceable condition (Figure 3 and Figure 4). Roof integrated gutters are located at the north and south edges of the roof, spanning the entire length of each edge. Roof drains are located within each integral roof gutter: three drains along the south gutter and three drains along the north gutter. WJE observed stains on the roof from ponding water within six feet of the gutter, along seams of the PVC membrane (Figure 5). The roof has 14 pipe penetrations that are flashed with preformed PVC boots and sealant. Existing vaulted skylights have been abandoned and covered with a metal standing seam roof with perimeter flashings. The PVC membrane extends onto the walls of the vaulted skylights, though the termination detail could not be observed below the metal standing seam cover. Biological growth exists across the vertical faces of the PVC membrane on the skylight vaults (Figure 6). An elevated electrical raceway is supported by DuraBlock rubber supports.

Figure 2. Overall view of gymnasium main roof and skylight vaults.

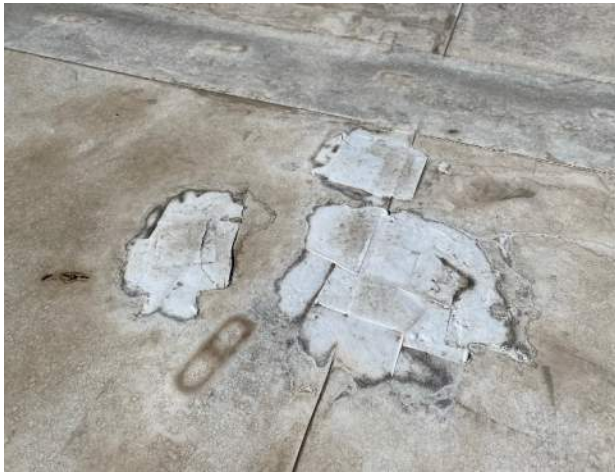
Figure 3. Sealant repair patch over PVC membrane at main roof.

The current ongoing construction at the PEK building, gymnasium, and ART building provides an opportunity to reroof the gymnasium with limited disruption to events that normally take place on campus in the vicinity of this building. At a minimum, the main roof should be permanently patched at roof core and other deficient locations and across the metal standing seam roof. Also, the fasteners that are disengaged from the underlying substrate should be drilled back into their former position and then sealed over with sealant.

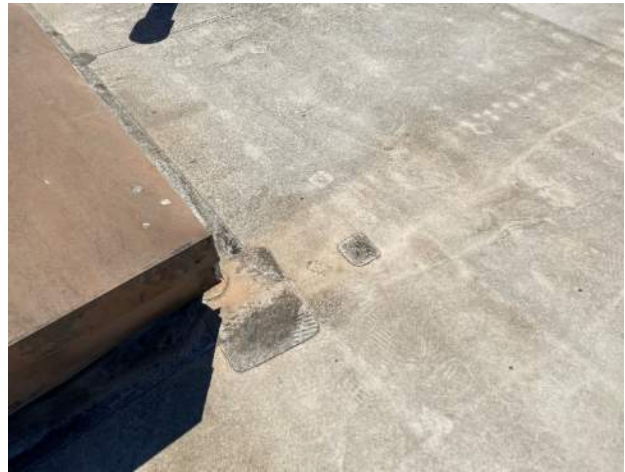
Figure 4. Corner detail patch and repair patch at main roof.

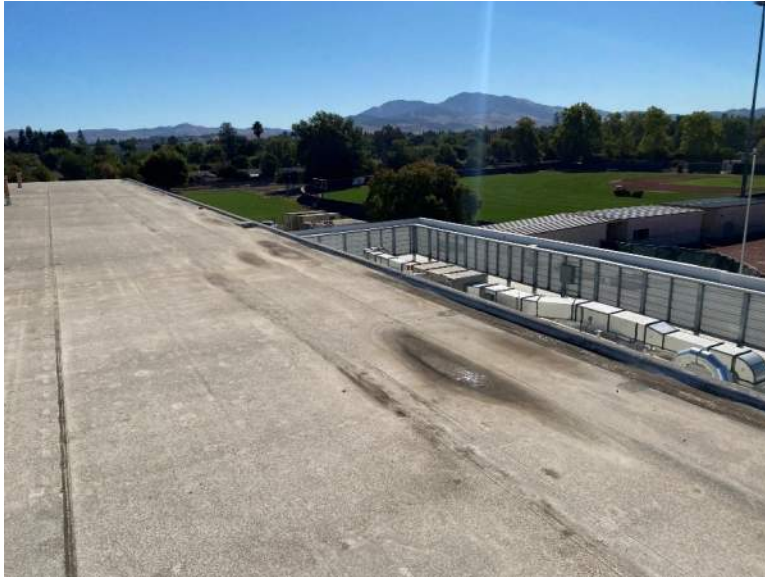
In its current state, the PVC roof assembly can likely provide six to ten years or more of useful service life if regularly inspected and maintained. Staining observed at seams in the PVC membrane do not appear to be adversely affecting the performance of the roofing assembly at this time. The roofing assembly at the main roof does not display deficiencies that warrant an immediate reroofing recommendation. WJE recommends engaging a qualified roofing contractor to perform annual or bi-annual roof inspection and maintenance services to monitor and repair the roof membrane before deficiencies arise.

Figure 5. Ponding stains commonly observed within six feet of gutters along PVC membrane seams.

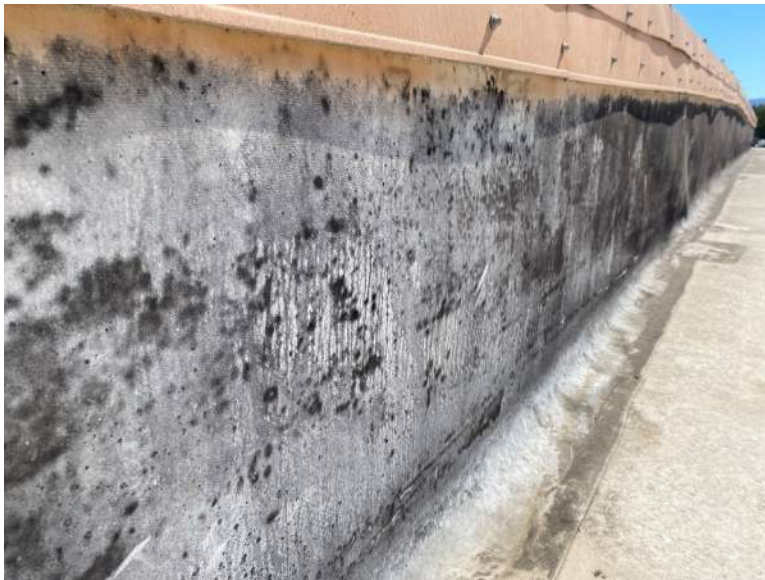
Figure 6. Biological growth is common on the vertical PVC application at the skylight vaults.

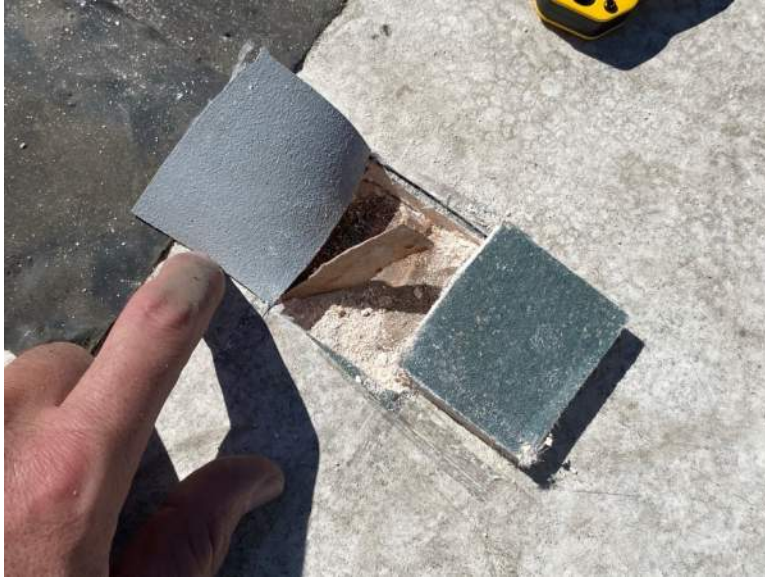
A total of three roof cores were taken at the main roof to observe the roofing assembly and the condition of the roof assembly. The PVC membrane is installed over a fiberglass-faced gypsum roof sheathing, over kraft paper, over a wood plank roof deck (Figure 7). A thin black membrane could be seen on the wood plank roof deck (Figure 8). WJE did not observe any evidence of moisture within the roof core locations.

Figure 7. Roof core made at gymnasium main roof.

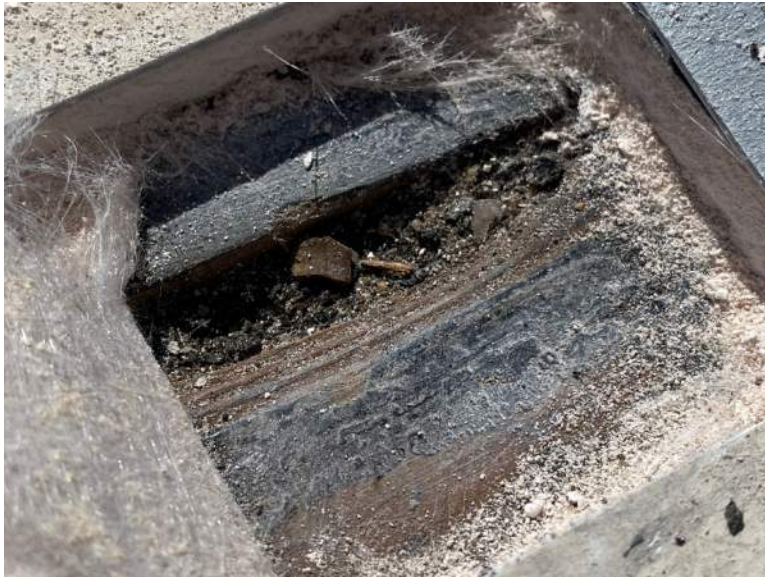
Figure 8. Thin black membrane is installed over the work plank roof deck.

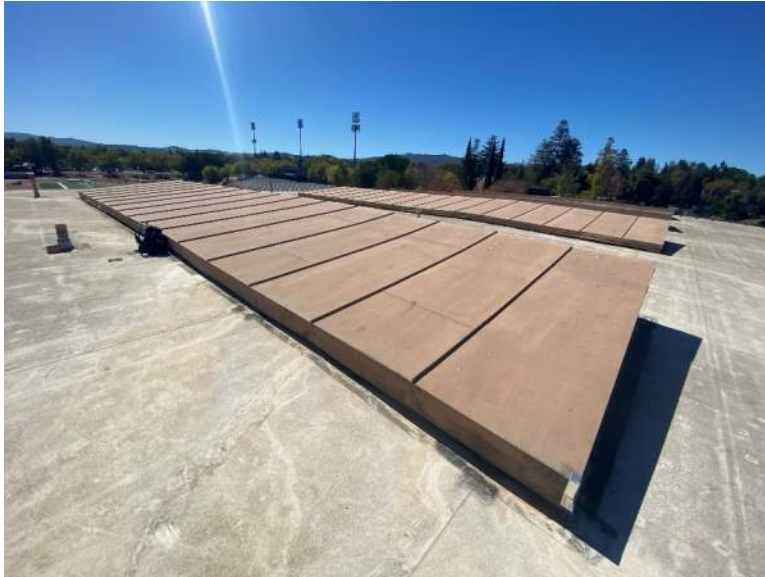
Each span of standing seam metal panel roofs includes two sections of sheet metal with seams. The metal standing seam roofs have some corrosion at seams and sealant failures at corner joints and lap seam joints (Figure 9). At some seam locations, an aluminum faced tape covers the seam (Figure 10 and Figure 11). The standing seams include intact rivets along the length of the standing seams. Several screw fasteners around the perimeter of the metal standing seam roof and the flashing below are disengaged from the underlying skylight vault framing (Figure 12 and Figure 13). Where the fasteners do not fully engage, there are likely holes through the PVC membrane that may cause leaks.

Figure 9. Overall view of a skylight vault, metal standing seam roof.

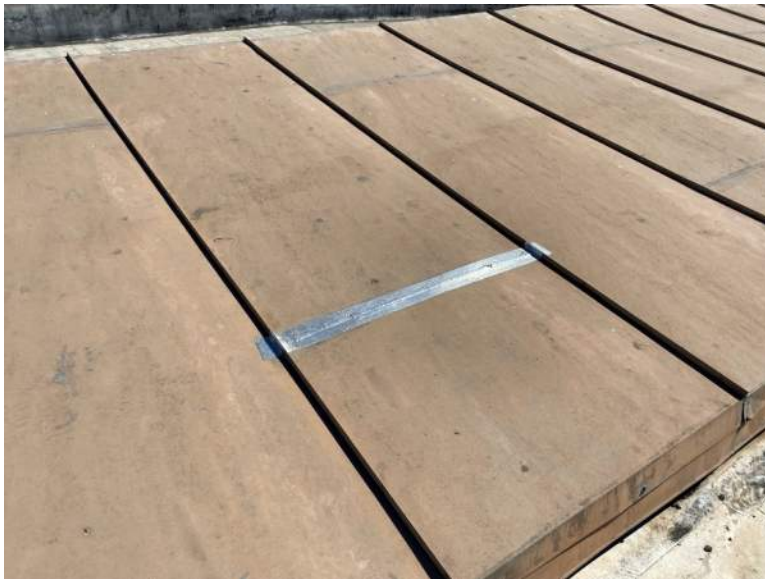
Figure 10. Aluminum-faced tape installed over lap seam joint in metal standing seam roof.

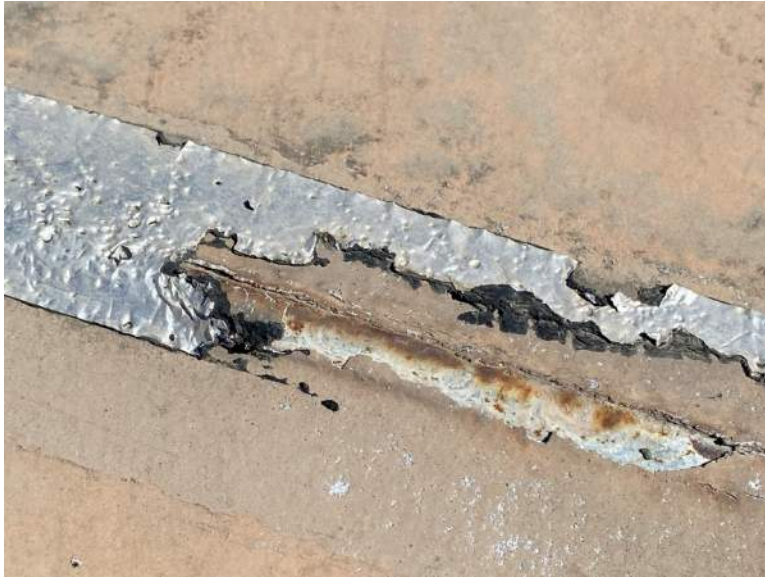
Figure 11. Corrosion observed at the lap seam condition where the aluminum faced tape has deteriorated.

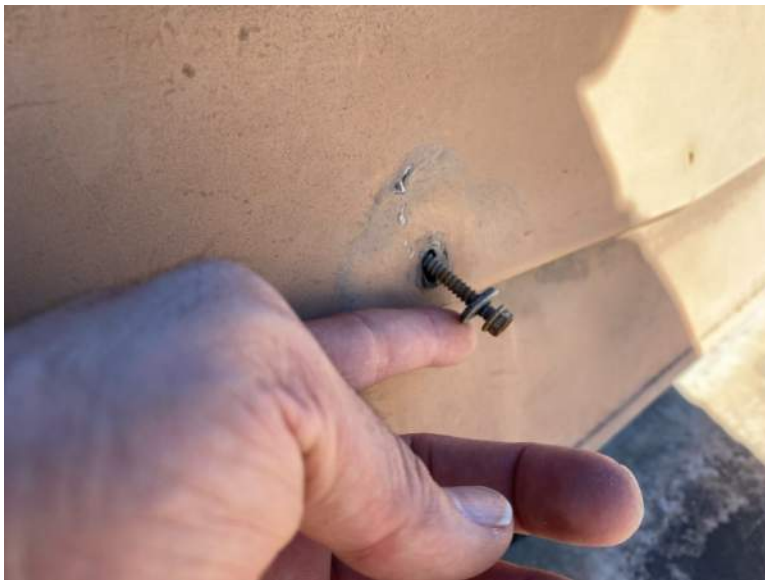
Figure 12. Disengaged fastener at the base of the metal standing seam roof.

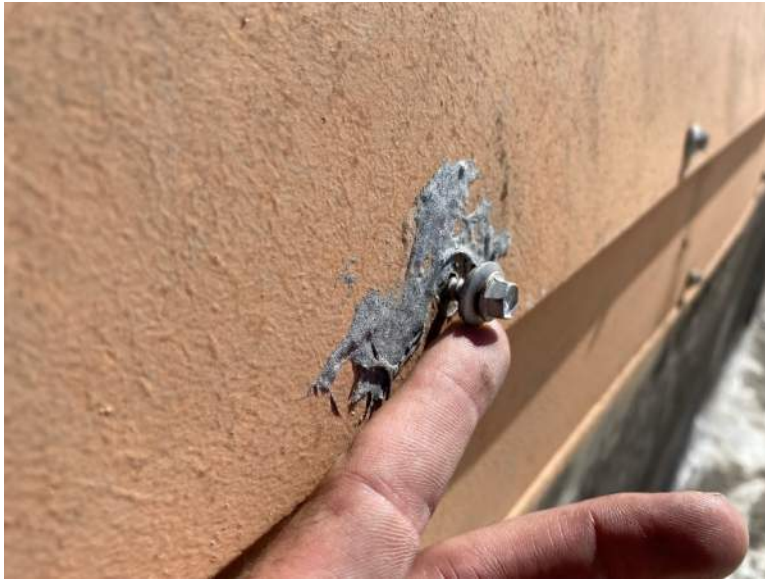
Figure 13. Disengaged fastener at the base of the metal standing seam roof with failed sealant.

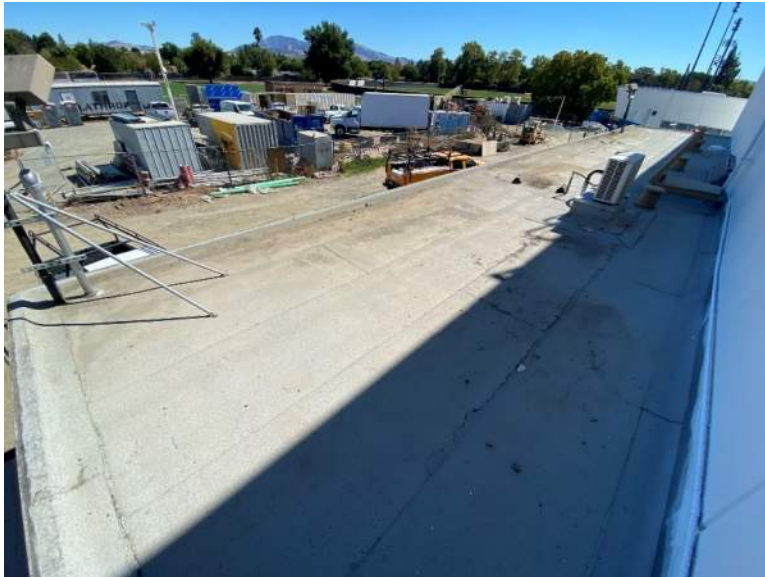
A canopy roof at the east entry of the gymnasium consists of a bituminous built-up roof with a granule-surfaced cap sheet (Figure 14). Staining was common along the east edge of the canopy, as it appears the roof is designed to permit overflow drainage onto the adjacent roof and ground level due to the absence of a roof drain (Figure 15). A lower canopy roof to the north of the main canopy has a gutter along its east edge (Figure 16). The complete built-up roofing assembly was measured to be 1/2 inch. A fiberglass - faced deck sheathing was observed below the built-up roofing assembly (Figure 17).

Figure 14. Overall view of upper canopy roof.

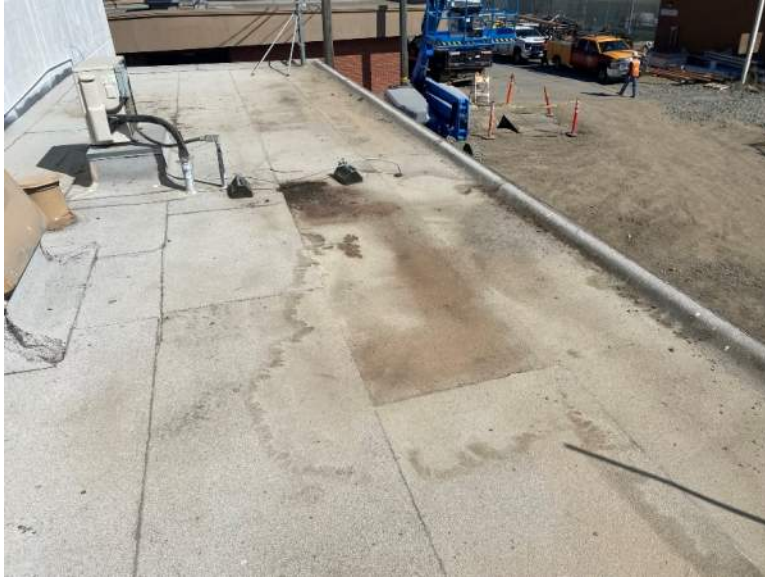
Figure 15. Moisture staining across the outer edge of the built-up roof membrane.

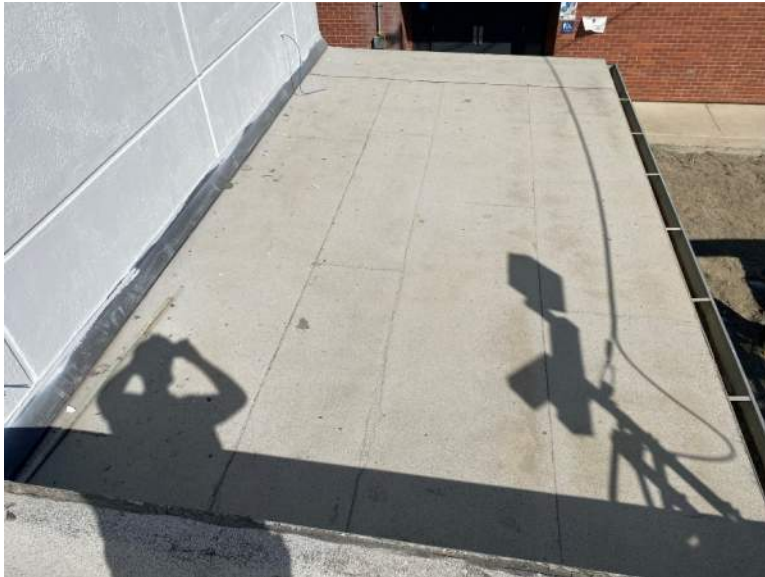
Figure 16. Overall view of lower canopy roof. Roof gutter spans the east edge of the roof.

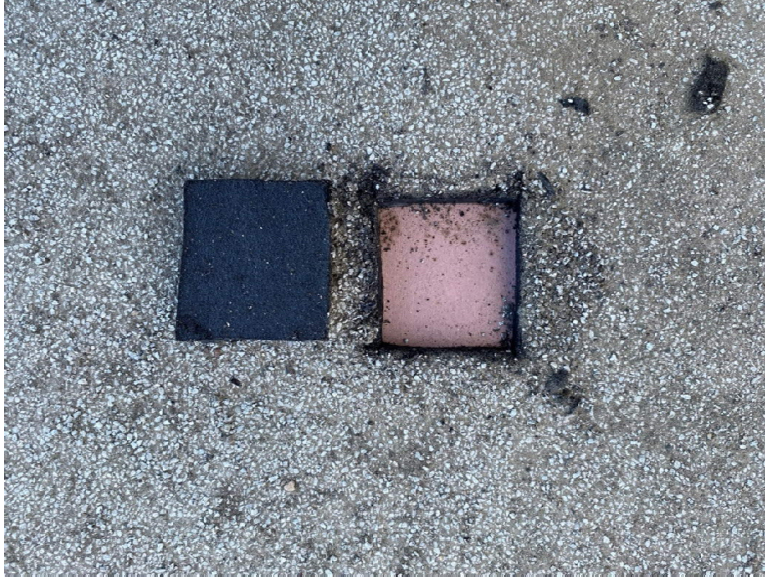
Figure 17. Roof core made at upper canopy roof.

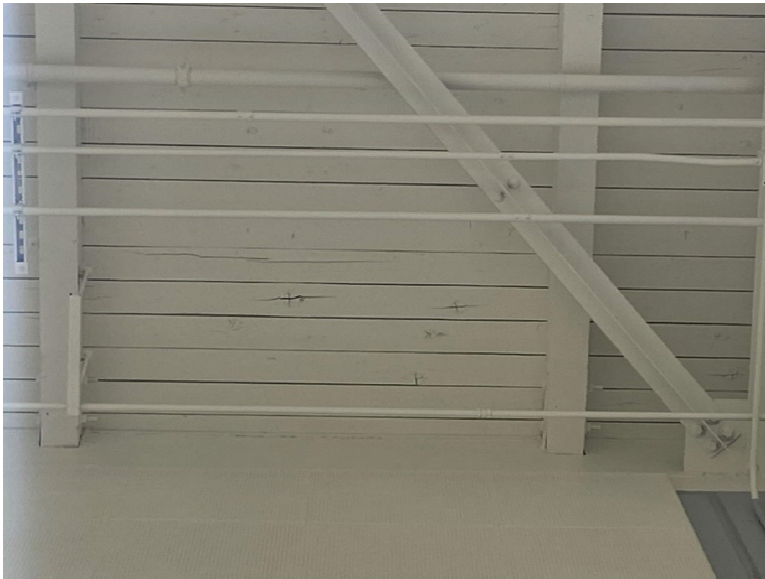
WJE observed the underside of the roof deck from the interior, including the skylight vaults, adjacent wall areas, and other rooms within the footprint of the gymnasium. Kitchell reported one previously repaired interior leak location at the head coach's office along the east edge of the gymnasium, directly below the overhang with the built-up roof assembly. We observed minimal paint cracking and staining on the underside of the wood plank roof deck (Figure 18 and Figure 19).

Figure 18. Underside of wood plank roof deck.

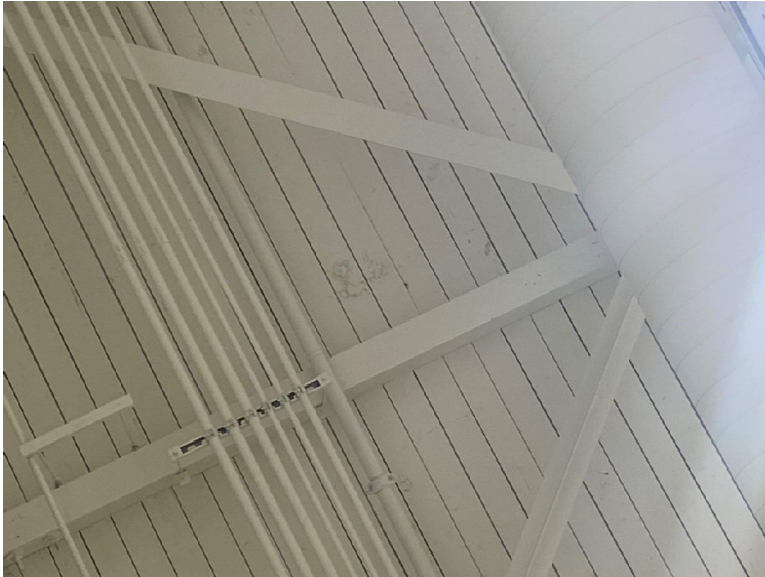
Figure 19. Paint peeling at the underside of the wood plank roof deck.

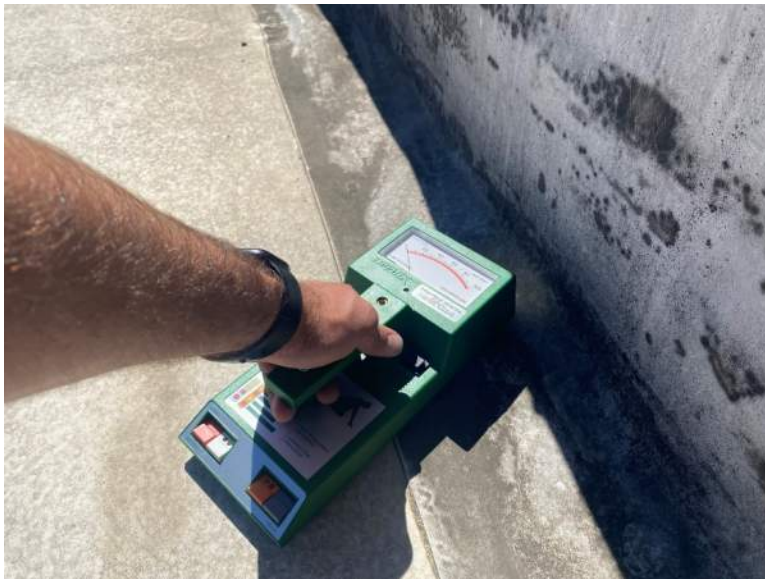
A moisture meter survey was completed to identify potential moisture trapped within the roofing assembly at the main roof. Moisture readings were taken in a grid pattern across the main roof and at various roofing seam conditions to assess any evidence of moisture in the roofing assembly. The moisture meter was calibrated to scan a single-ply roofing membrane with a high-signal sensitivity level. Each surveyed roof location displayed a moisture reading of zero on the moisture relative scale, indicating that the moisture meter was unable to detect moisture within the PVC roofing assembly (Figure 20).

Figure 20. Tramex moisture meter used across the roof deck to assess moisture content of roof assembly.
