Pre-Demolition Hazardous Materials Survey

2700 East Leland Road
Pittsburg, California

July 13, 2022

Terracon Project No. R1227237

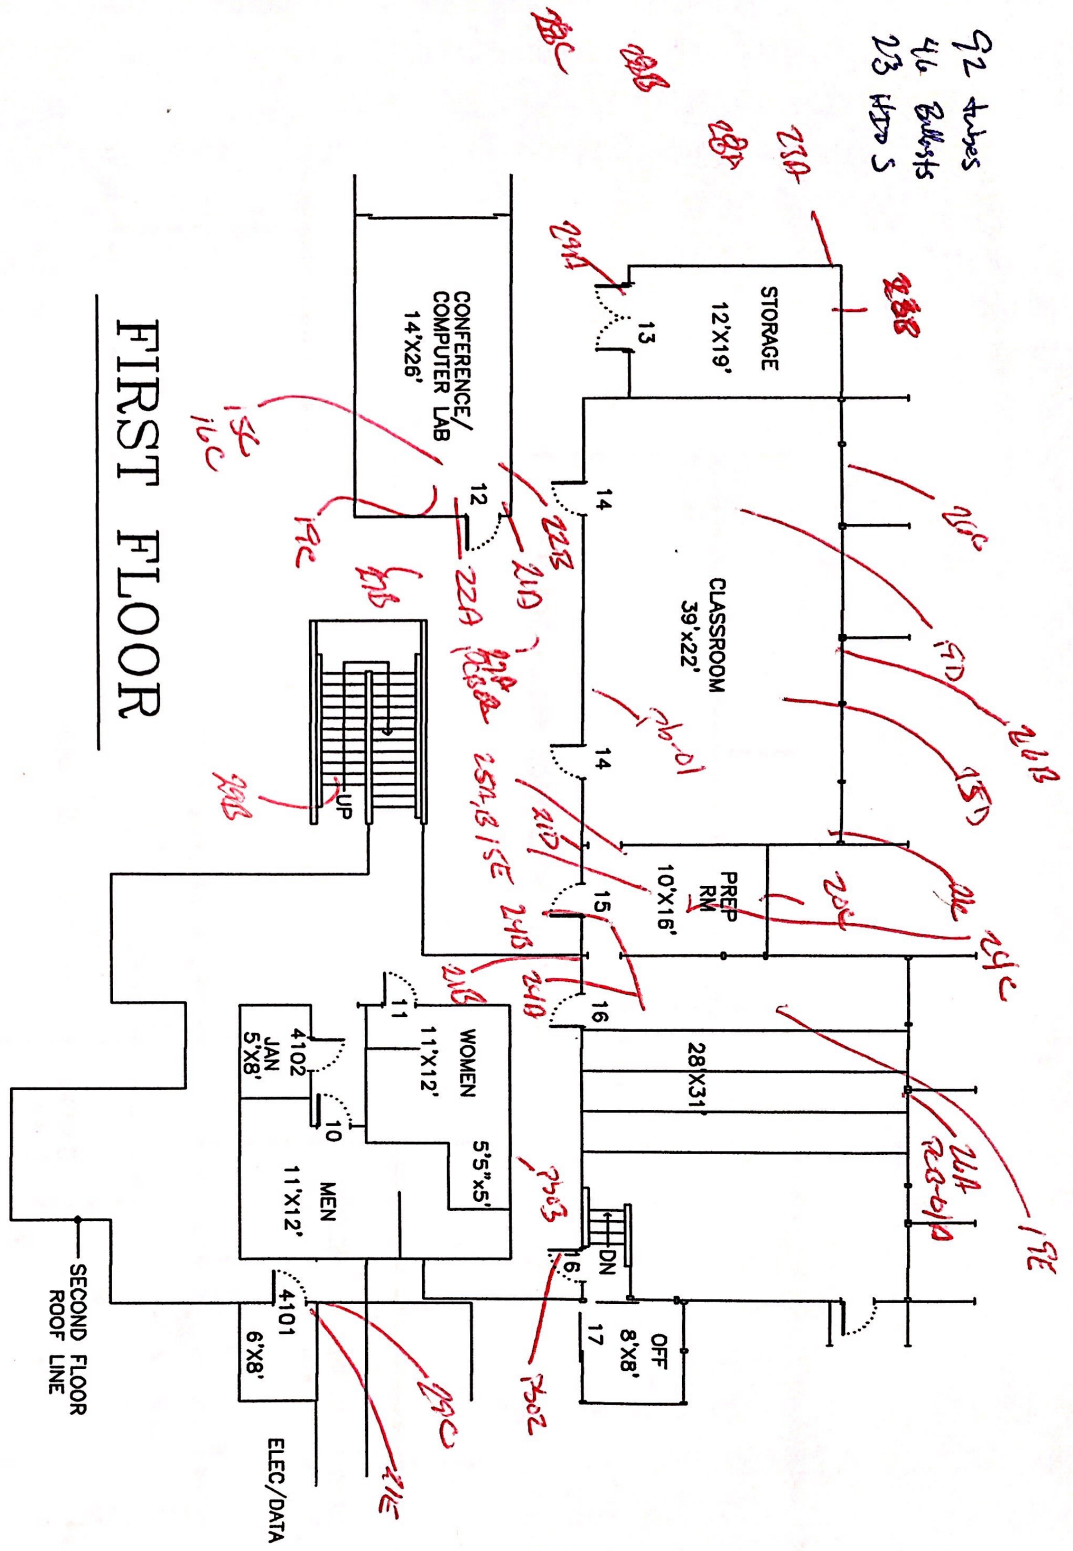
FIRST FLOOR

92 tubes
46 Balists
23 H2O S
