- Attn: Mr. Stefan Johnson Critical Solutions
- RE: Limited Pre-Renovation Asbestos and Lead Survey Report Los Medanos College – Votech Roof 2700 East Leland Road, Pittsburg, CA Terracon Project #: R1227233

Terracon Consultants, Inc. (Terracon) conducted a limited pre-renovation asbestos and lead survey of the Votech Building roof on the Los Medanos College (LMC) campus located at 2700 East Leland Road, Pittsburg, California, on May 3, 2022.

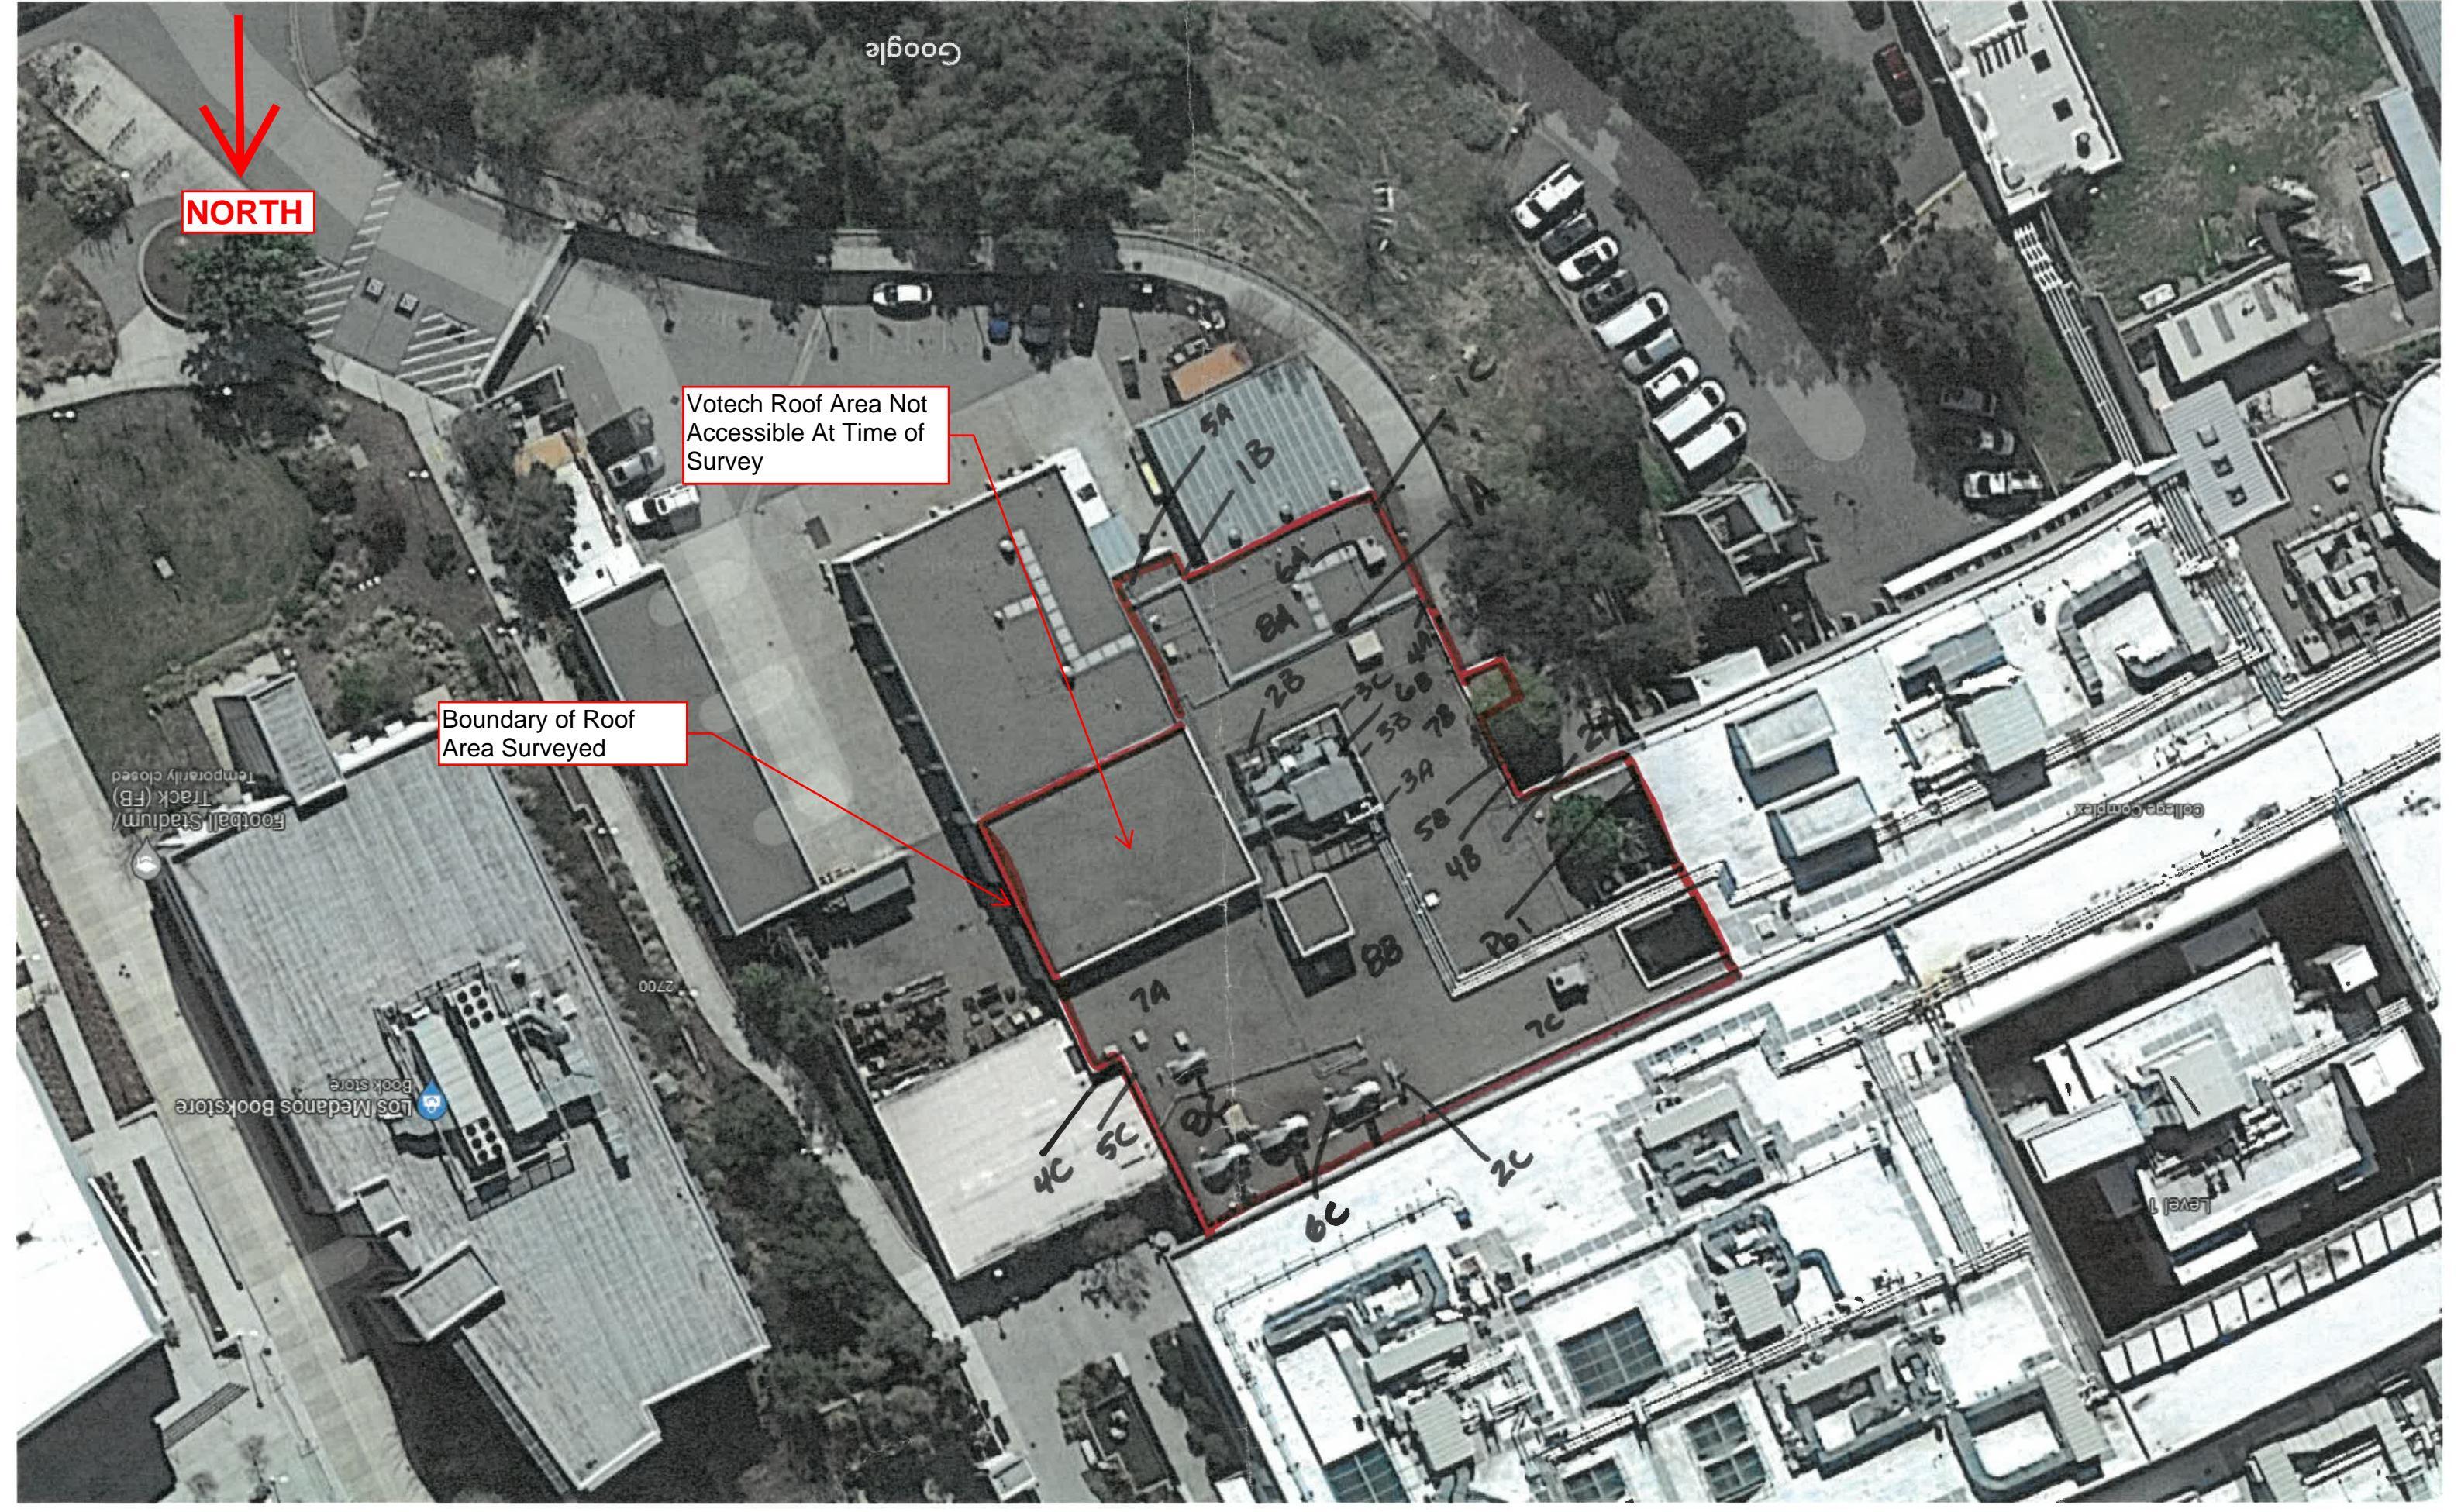
It should be noted that Terracon could not access a portion of the roof area at the southeast corner as depicted on the sample location diagram. The materials identified as asbestos-containing in the table above should be assumed present at this portion of the building. Additionally, there is asbestos-containing roofing debris mixed with the aggregate (HM #07). Therefore, the aggregate/gravel should be properly abated and disposed of as asbestos-containing material.
