ADDENDUM #2

CONTRA COSTA COMMUNITY COLLEGE DISTRICT

C-4016, INC. 3, DEMO AND ABATEMENT OF PHYSICAL SCIENCE AND BIOLOGICAL SCIENCE BUILDINGS AND OTHER STRUCTURES

Date: December 13, 2021

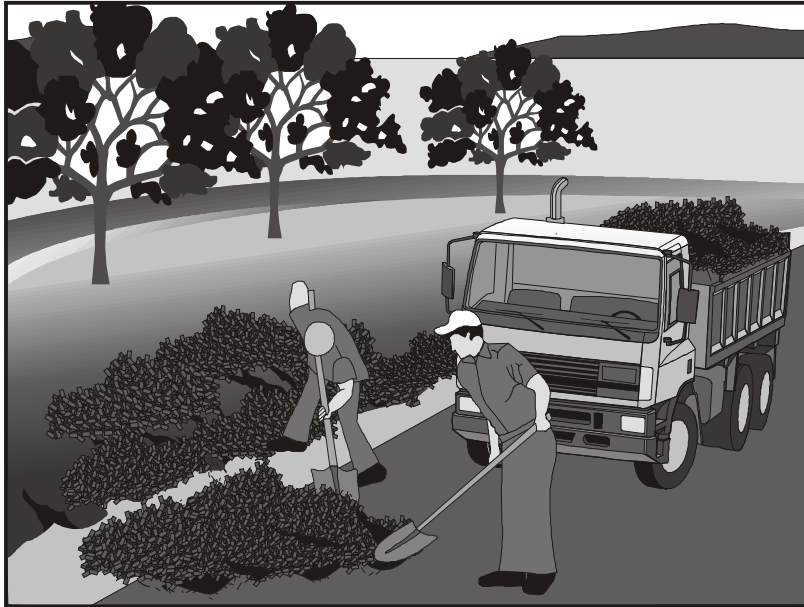
TYPICAL INSTALLATION DETAIL

1. Check slots to be constructed per manufacturers specifications.
2. Staking or stapling layout per manufacturers specifications.
3. Install per manufacturer's recommendations

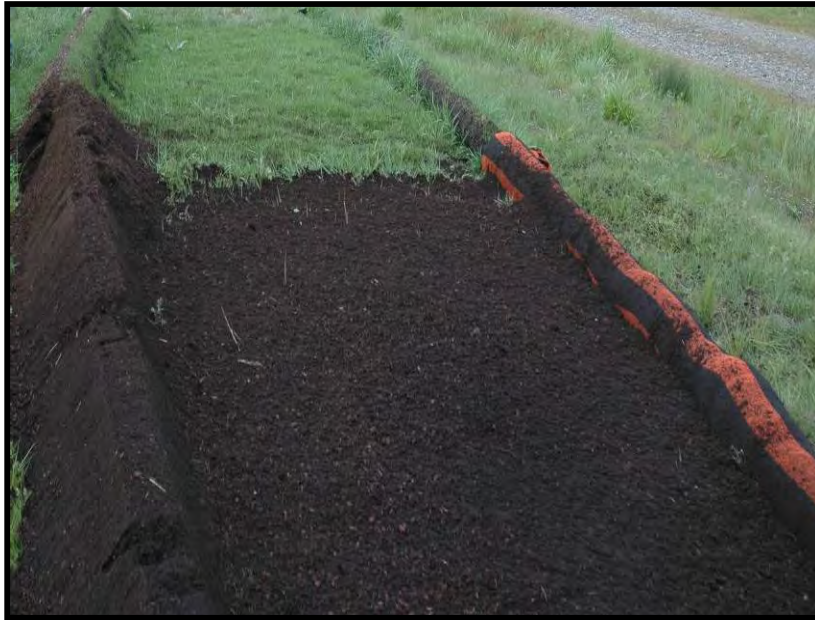
A compost blanket is applied to slopes and earth disturbed areas to prevent erosion, and in some cases, increase infiltration and/or establish vegetation. The compost blanket can be applied by hand, conveyor system, compost spreader, or pneumatic delivery (blower) system. The blanket thickness is determined from the slope steepness and anticipated precipitation. A compost blanket protects the soil surface from raindrop erosion, particularly rills and gullies that may form under other methods of erosion control.

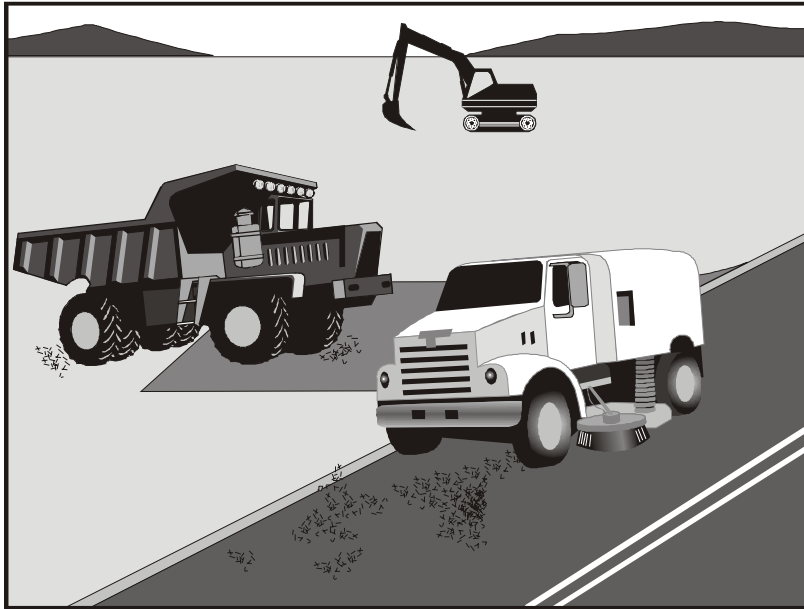
Street sweeping and vacuuming includes use of self-propelled and walk-behind equipment to remove sediment from streets and roadways, and to clean paved surfaces in preparation for final paving. Sweeping and vacuuming prevents sediment from the project site from entering storm drains or receiving waters.

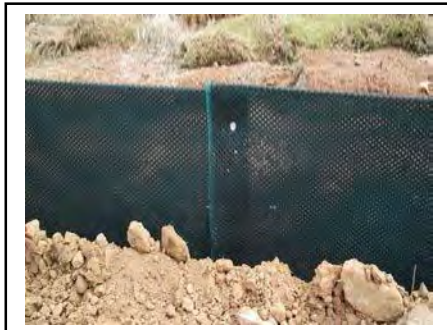
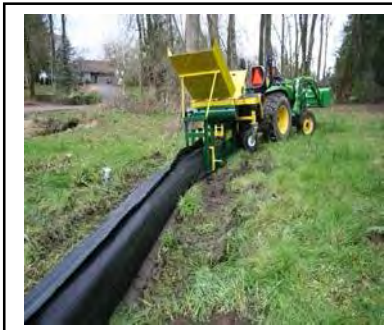
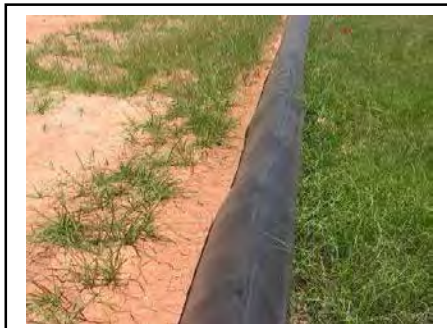
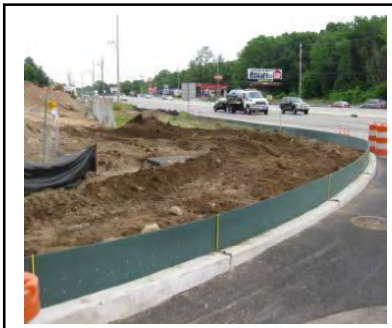
Manufactured Linear Sediment Controls (MLSC)

Manufactured linear sediment controls (MLSC) are pre-manufactured devices that are typically specified and installed for drainage and sediment control on the perimeter of disturbed sites or stockpiles and as check dams within channels. Typically, MLSCs can be reused.

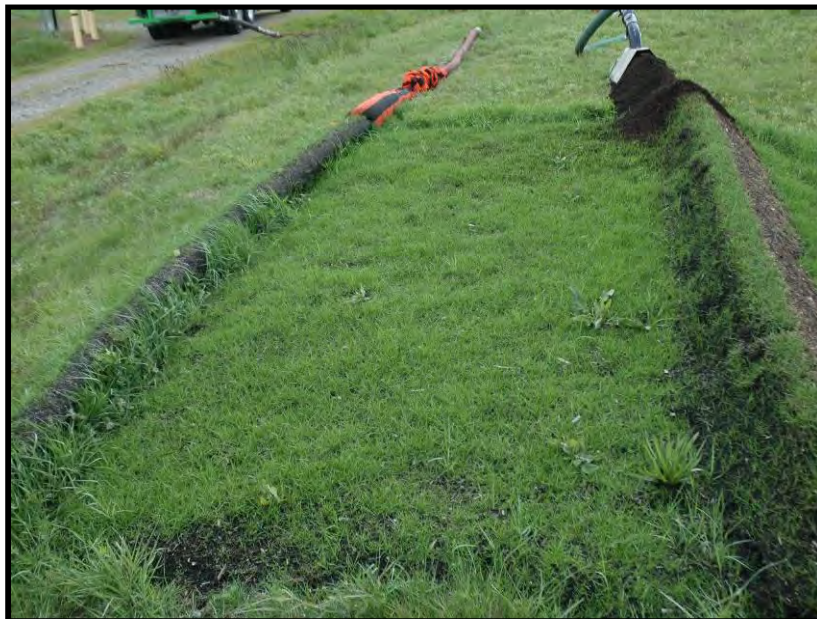
Compost socks and berms act as three-dimensional biodegradable filtering structures to intercept runoff where sheet flow occurs and are generally placed at the site perimeter or at intervals on sloped areas. Compost socks are generally a mesh sock containing compost and a compost berm is a dike of compost, trapezoidal in cross section. When employed to intercept sheet flow, both BMPs are placed perpendicular to the flow of runoff, allowing filtered runoff to pass through the compost and retaining sediment (and potentially other pollutants). A compost sock can be assembled on site by filling a mesh sock (e.g. with a pneumatic blower). The compost berm should be constructed using a backhoe or equivalent and/or a pneumatic delivery (blower) system and should be properly compacted. Compost socks and berms act as filters, reduce runoff velocities, and in some cases, aid in establishing vegetation.

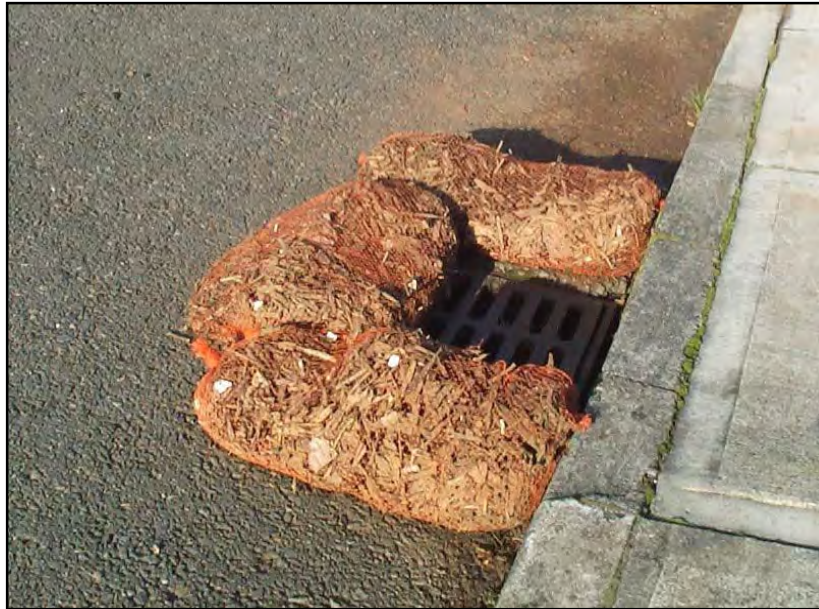
Biofilter bags, or bio-bags, are a multi-purpose sediment control BMP consisting of a plastic mesh bag filled with 100% recycled wood product waste. Biofilter bags come in a variety of sizes (30" x 18" and 30" x 9" being common) and generally have between 1-2 cubic yards of recycled wood waste (or wood chips). Biofilter bags work by detaining flow and allowing a slow rate of discharge through the wood media. This action removes suspended sediment through gravity settling of the detained water and filtration within the bag.

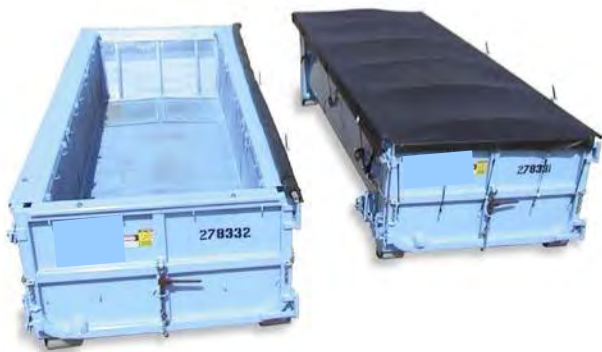
Dewatering Tanks

- A dewatering tank removes debris and sediment. Flow enters the tank through the top, passes through a fabric filter, and is discharged through the bottom of the tank. The filter separates the solids from the liquids.

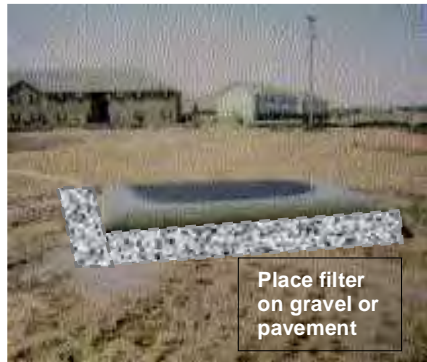
Gravity Bag Filter

- A gravity bag filter, also referred to as a dewatering bag, is a square or rectangular bag made of non-woven geotextile fabric that collects gravel, sand, silt, and fines.

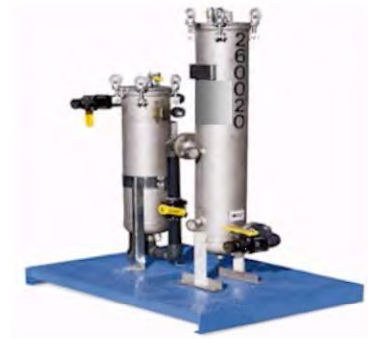
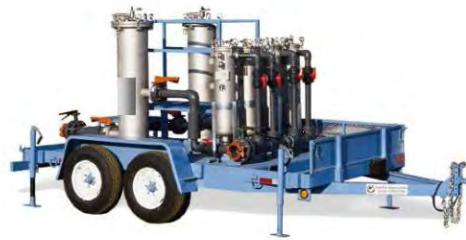
Pressurized Bag Filter

- A pressurized bag filter is a unit composed of single filter bags made from polyester felt material. The water filters through the unit and is discharged through a header. Vendors provide bag filters in a variety of configurations. Some units include a combination of bag filters and cartridge filters for enhanced contaminant removal.
