BID DOCUMENTS COVER SHEET

***C-4016, Inc. 3, Demo and Abatement of Physical
Science and Biological Science Buildings
and other Structures***

Contra Costa College
2600 Mission Bell Dr., San Pablo, CA 94806

CONTRA COSTA COMMUNITY COLLEGE DISTRICT

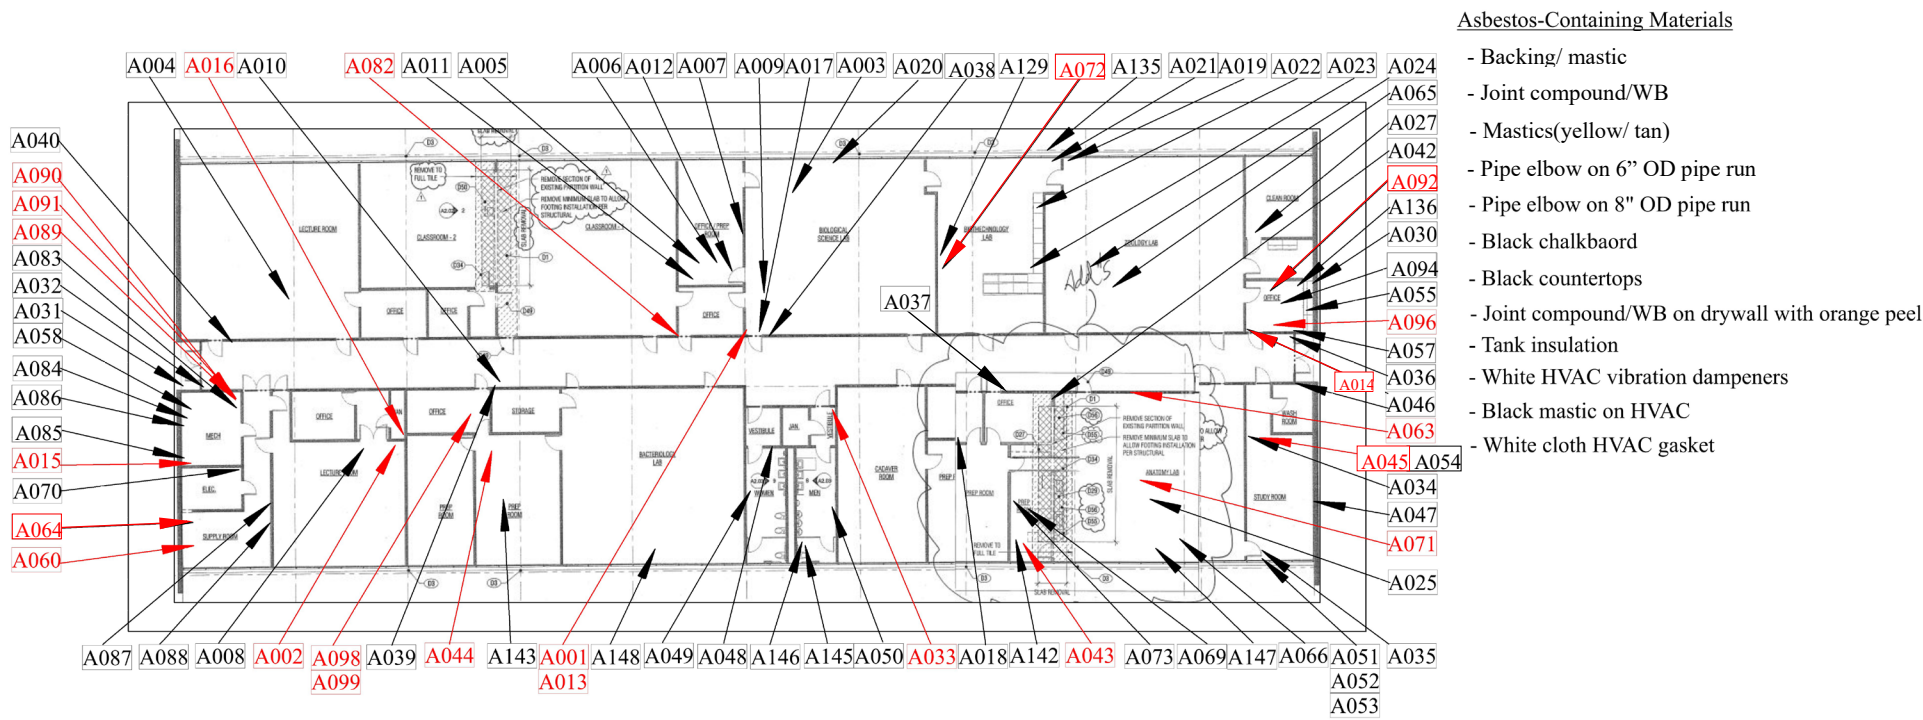
Biological Science Building – Asbestos Sample Location Map, Page 1

- Asbestos-Containing Materials**
- Backing/ mastic
 - Joint compound/WB
 - Mastics(yellow/ tan)
 - Pipe elbow on 6" OD pipe run
 - Pipe elbow on 8" OD pipe run
 - Black chalkboard
 - Black countertops
 - Joint compound/WB on drywall with orange peel
 - Tank insulation
 - White HVAC vibration dampeners
 - Black mastic on HVAC
 - White cloth HVAC gasket

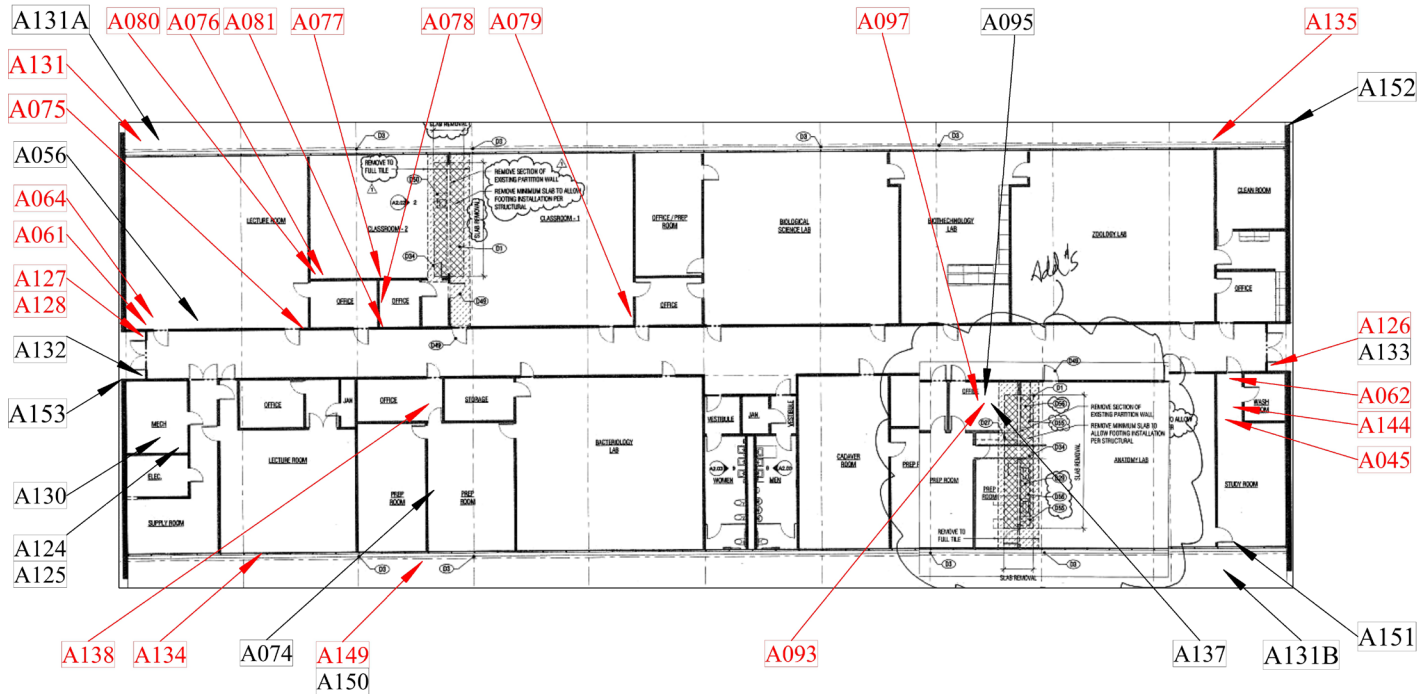
Asbestos-Containing Materials

- Pipe elbow on 6" OD pipe run
- Black chalkboard
- Texture
- Joint compound/WB on drywall with orange peel
- White HVAC vibration dampeners
- Black mastic on HVAC
- Skim coat
- Concrete slab exterior
- Light gray caulk exterior

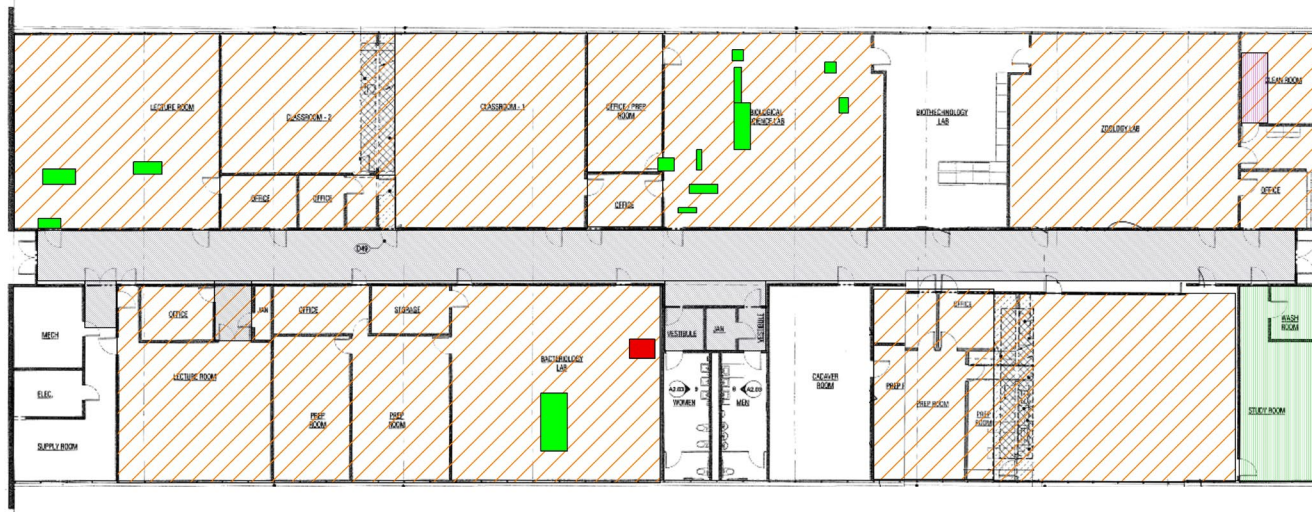
Positive Asbestos Bulk Sample Location: **BIO – A045, A061, A062, A064, A075-A081, A093, A097, A126-A128, A131, A134, A135, A138, A144, A149**

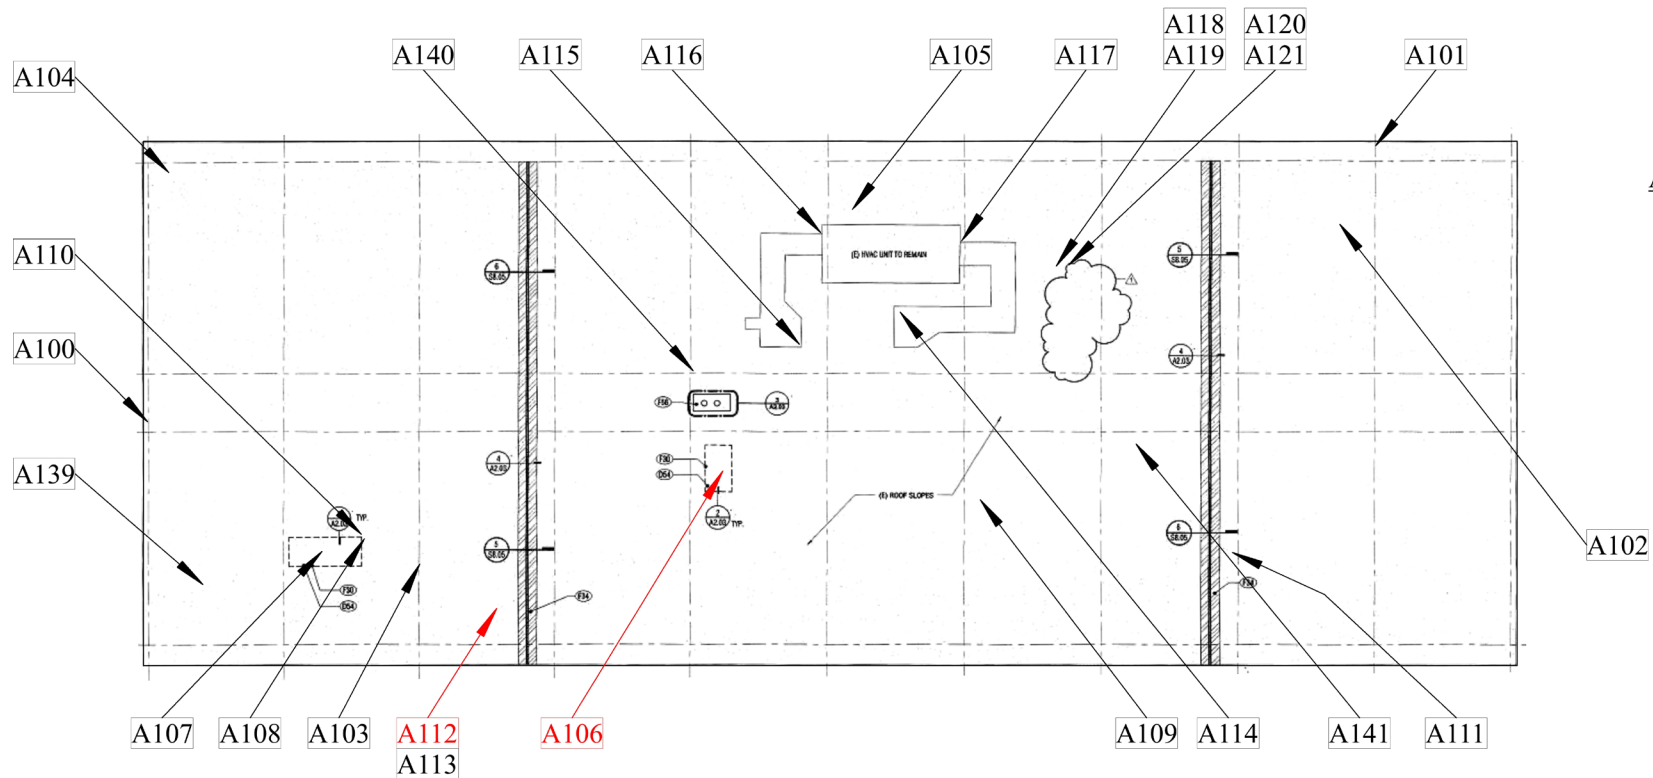
Asbestos-Containing Materials

- Paint (silver)
- Dark gray sealant

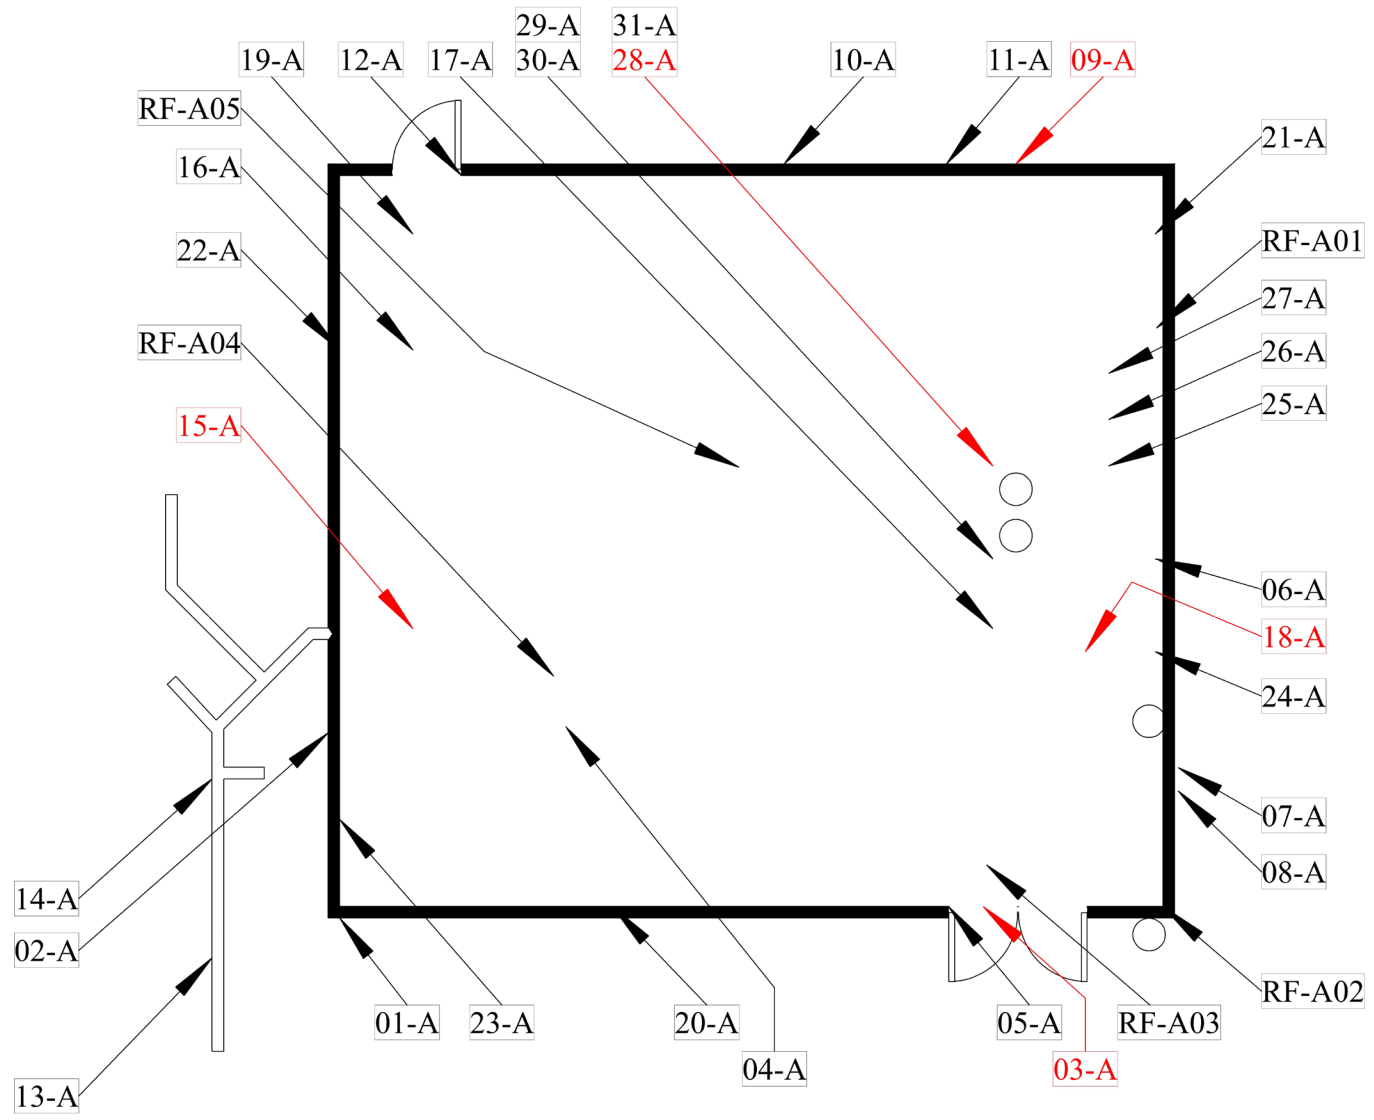
Asbestos-Containing Materials

- Concrete
- Sealant
- TSI

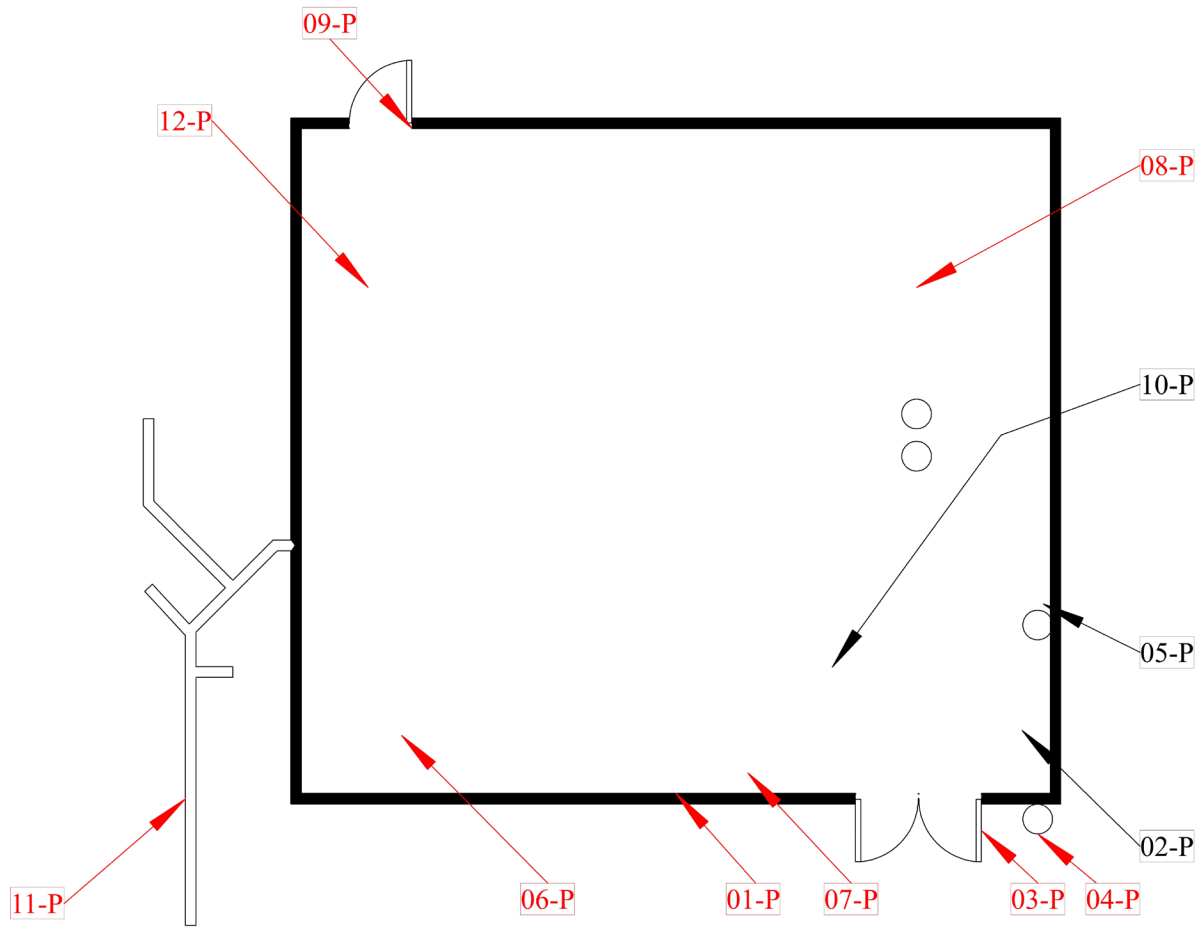
Lead-Containing Materials

- Pink paint on concrete wall
- Brick red paint on metal door
- Brick red paint on metal pipe
- Ferrari red paint on metal pipe flange/caps
- Yellow paint on metal pipes/flanges
- Blue paint on TSI
- Blue paint on metal doorframe
- Grey paint on metal pipe
- Grey paint on metal pedestal

Positive Lead Bulk Sample Location: BR – 01-P, 03-P, 04-P, 06-P,
 07-P, 08-P, 09-P, 11-P, 12-P

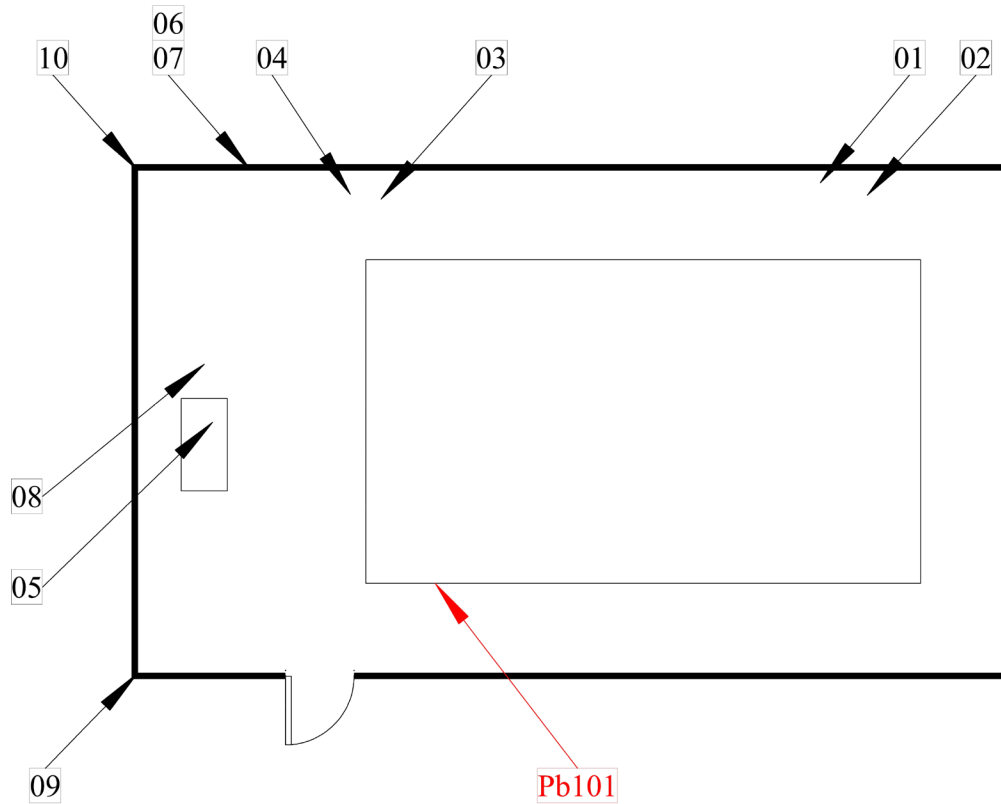
Lead-Containing Materials

- Gray paint on metal chiller component

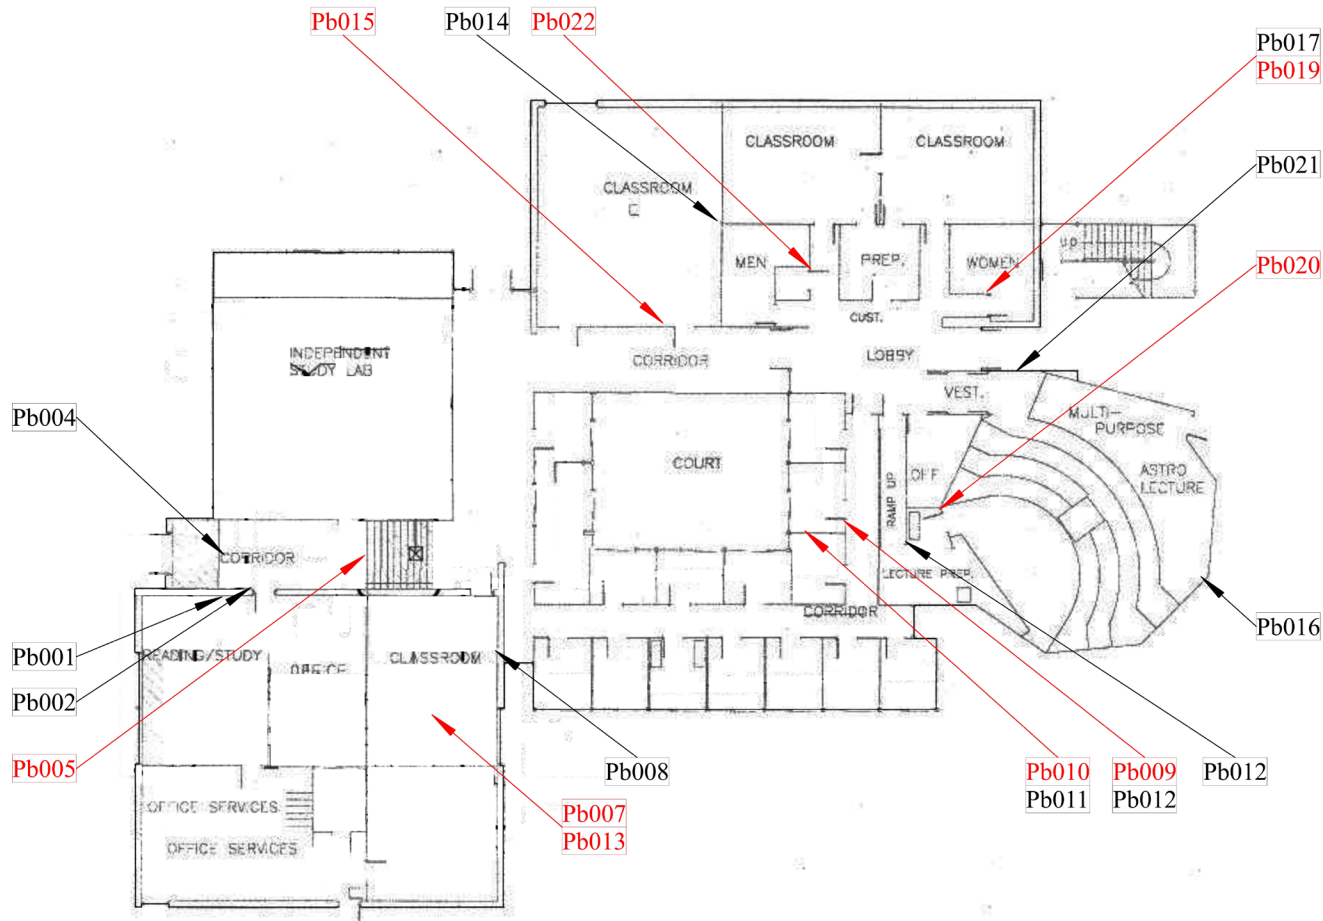
Lead-Containing Materials

- Gray paint on metal handrail
- Red paint on metal duct
- Black paint on metal doorframe
- White paint on metal doorframe
- Yellow paint on metal fixture
- Brown paint on metal doorframe
- Red ceramic wall tile
- Yellow paint on gypsum board wall
- Red paint on metal beam

Positive Lead Bulk Sample Location: **PSBN – Pb005, Pb007, Pb009, Pb010, Pb013, Pb015, Pb019, Pb020, Pb022**

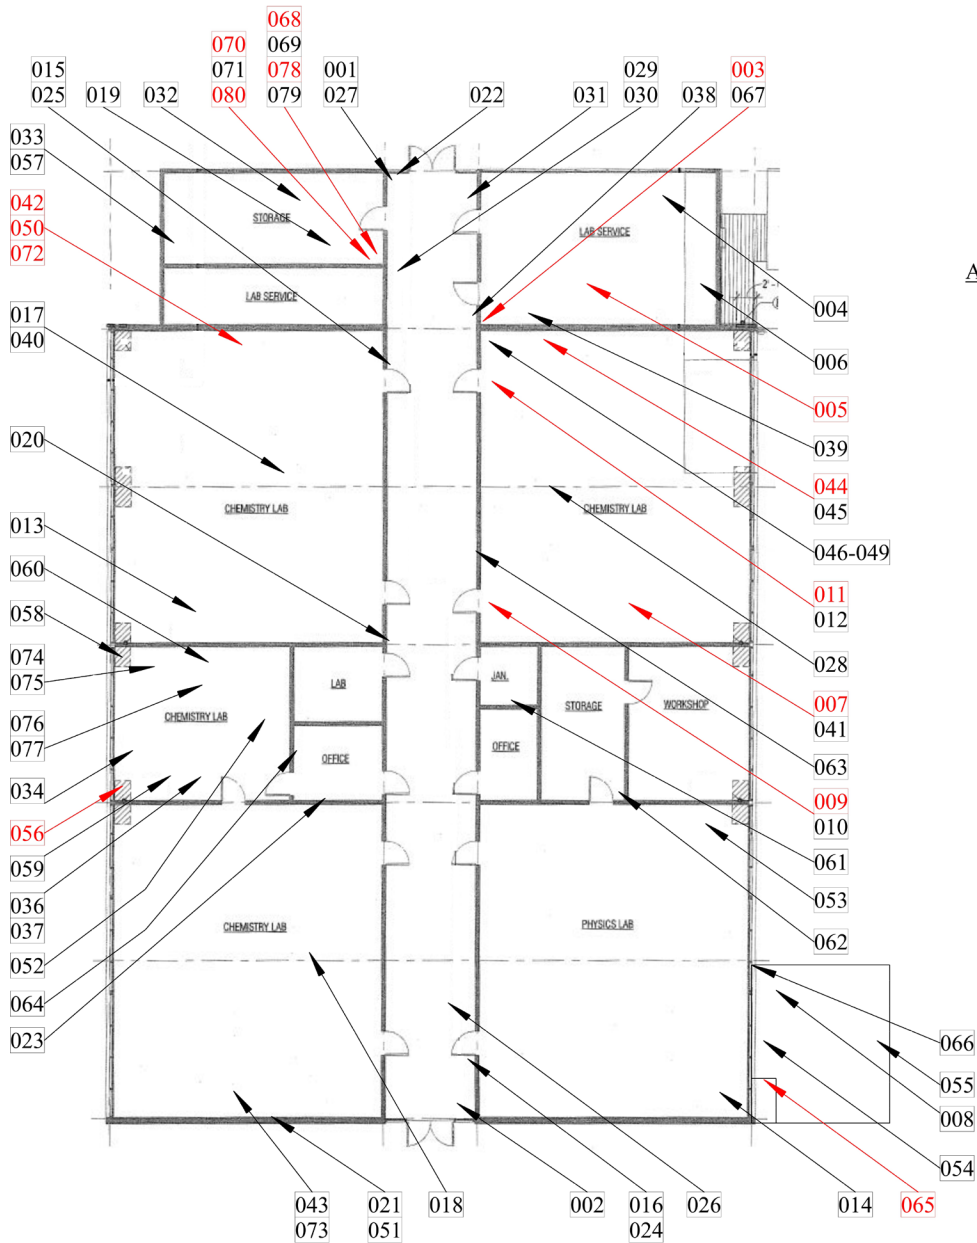
Asbestos-Containing Materials

- 9" x 9" Tan w/ brown streaks FT over black mastic
- 12" x 12" Beige w/ dark brown and white streaks FT over black mastic
- 12" x 12" Dark gray w/ white streaks FT over black mastic
- 12" x 12" Red w/ black streaks FT over black and yellow mastic
- 12" x 12" Light brown w/ white streaks FT over yellow mastic
- Black exhaust system table top
- Gray exhaust system transite panel
- Black exhaust system transite panel
- Wallboard/ joint compound
- Off-white transite pipe fitting
- Pipe penetration tape and insulation
- Transite exhaust hood
- White transite pipe

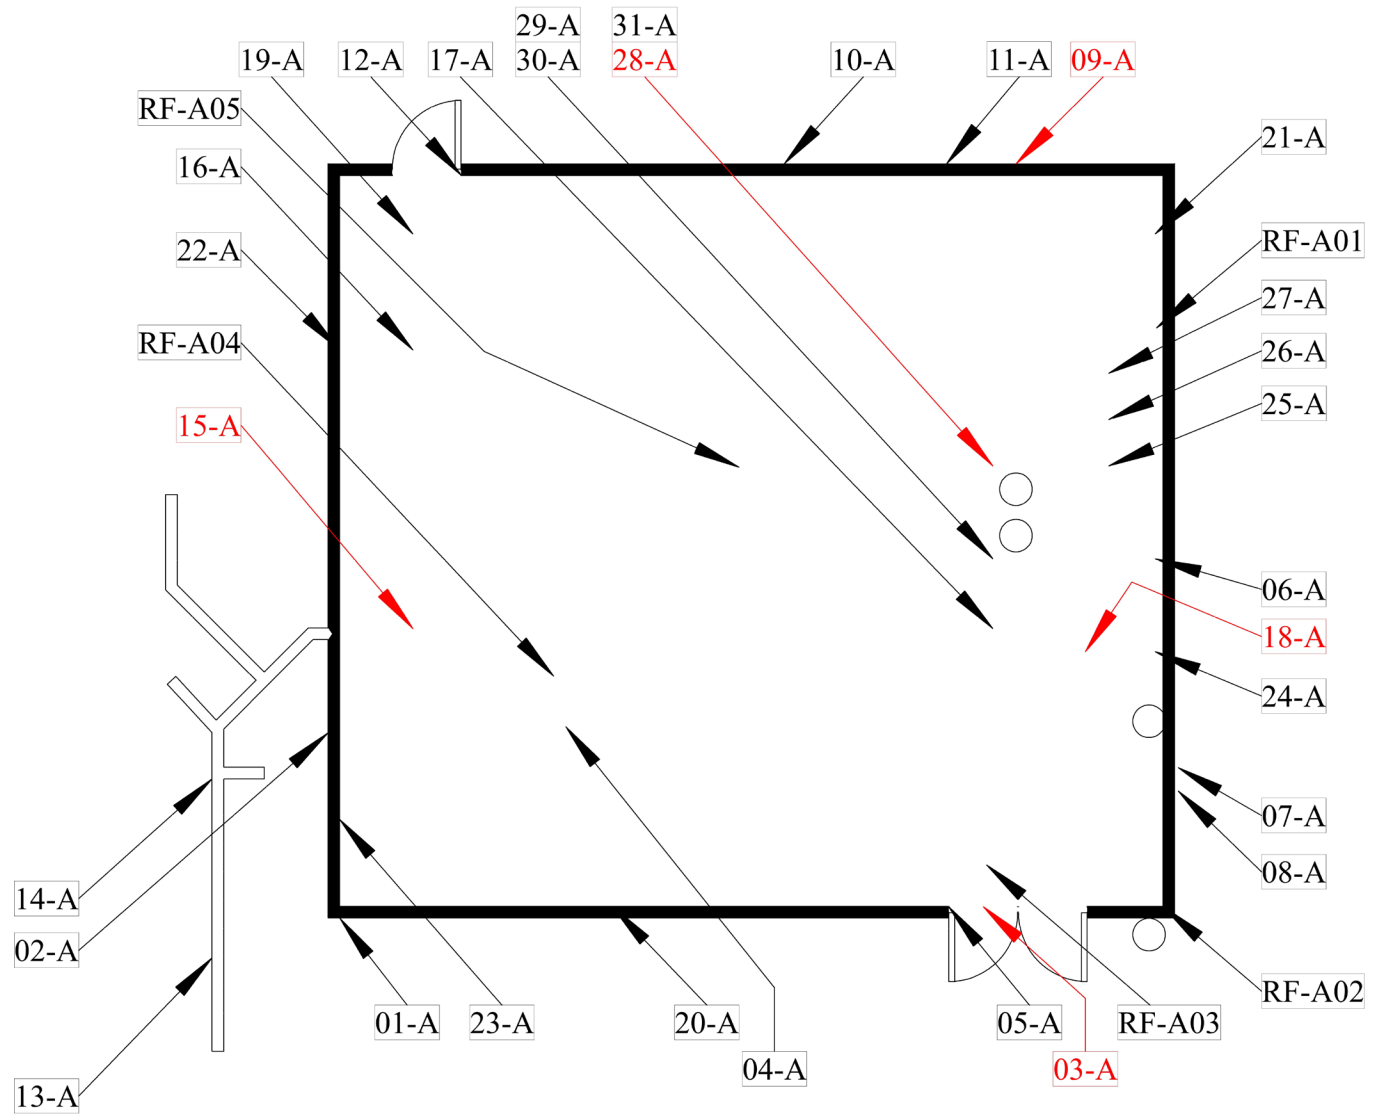
Asbestos-Containing Materials

- Concrete
- Sealant
- TSI

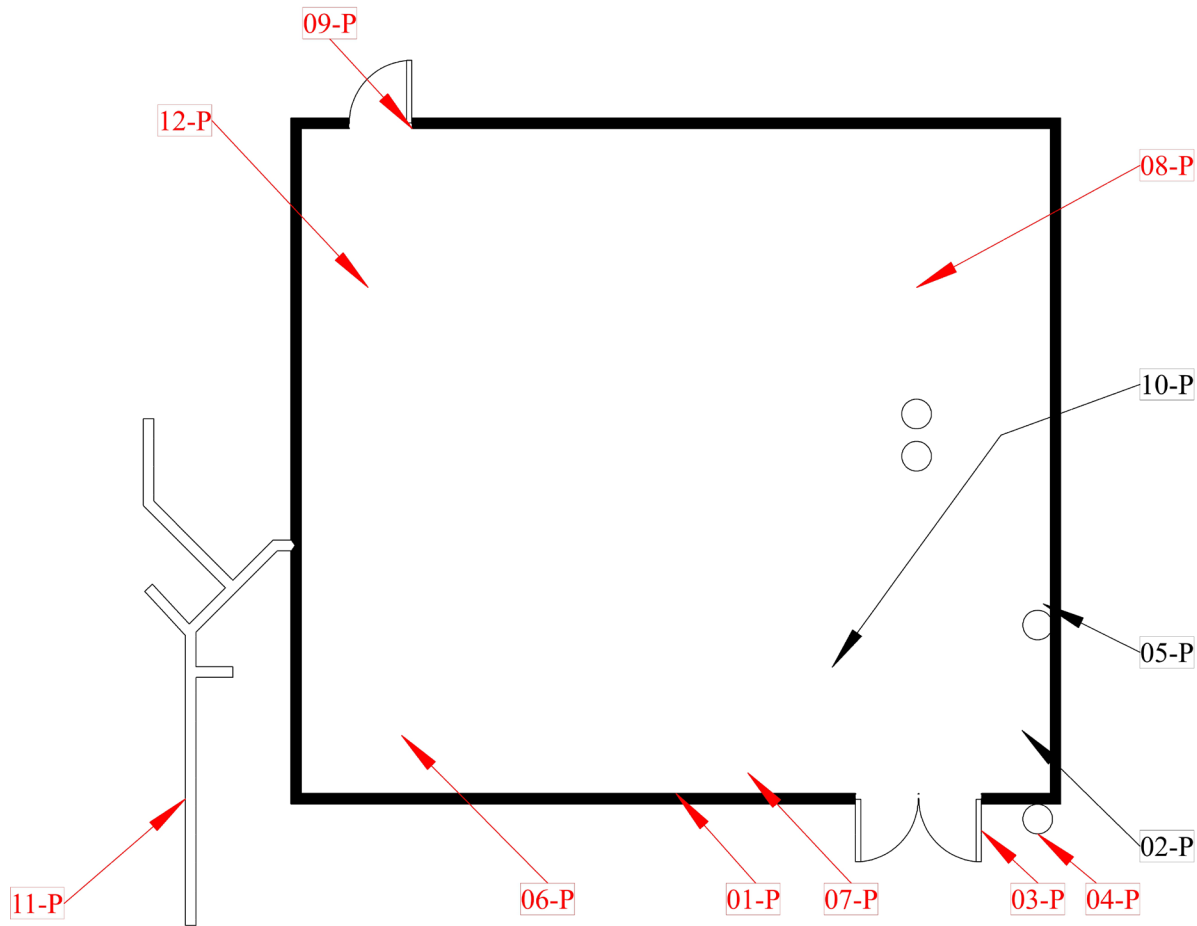
Lead-Containing Materials

Positive Lead Bulk Sample Location: BR – 01-P, 03-P, 04-P, 06-P,
 07-P, 08-P, 09-P, 11-P, 12-P
