ADDENDUM # 1

CONTRA COSTA COMMUNITY COLLEGE DISTRICT

Project: ENGINEERING TECHNOLOGY BUILDING RENOVATION PROJECT DESIGN-BUILD SERVICES RFQ
Campus/Location: Diablo Valley College, Pleasant Hill, CA

Date: 6/21/2023

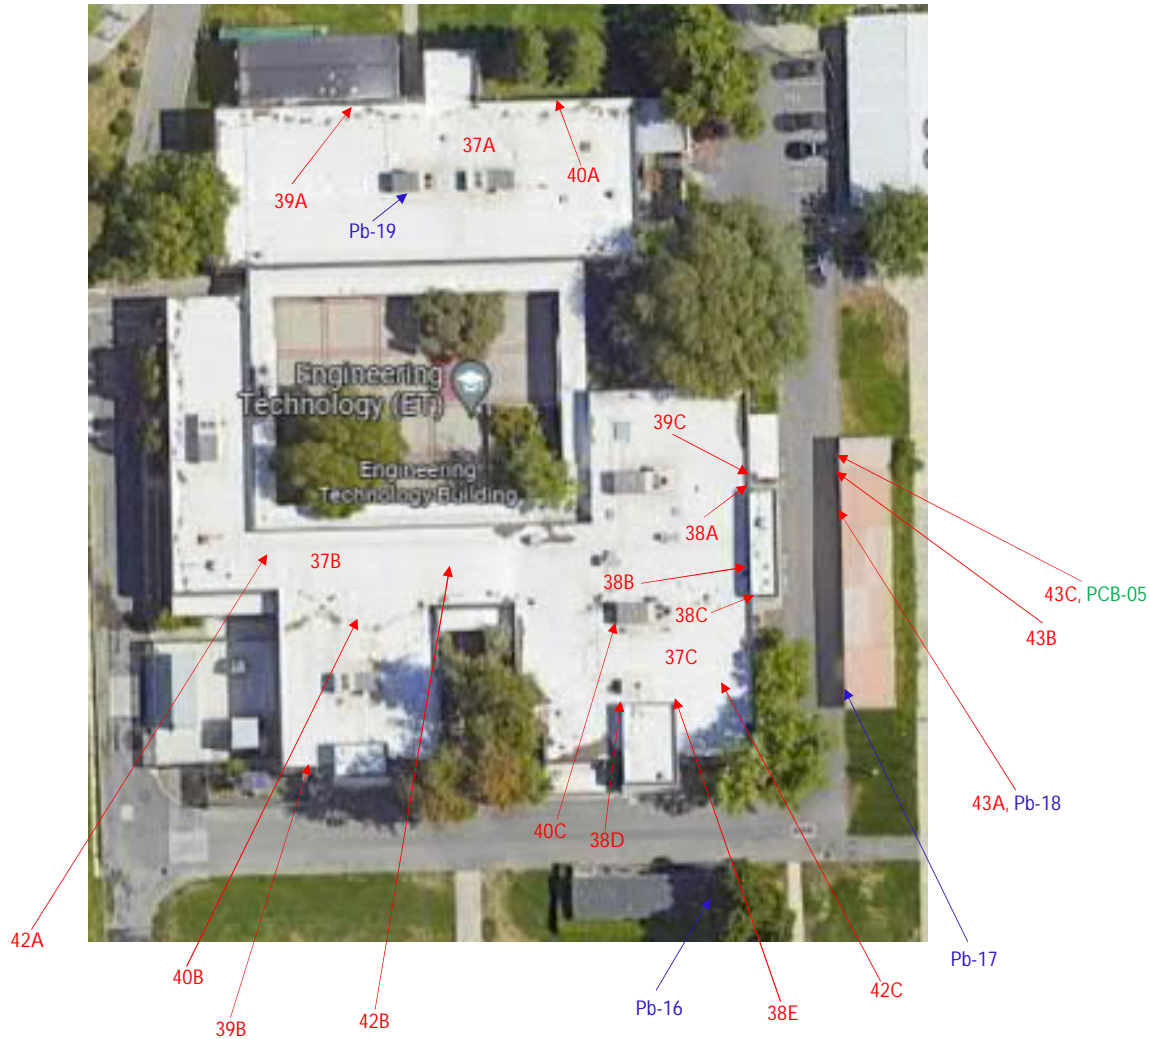
Engineering Technology
(ET) Building
Roof & Additional
Structures

321 Golf Club Road
Pleasant Hill, California

↑
N
Not to Scale
