**GEOTECHNICAL ENGINEERING
INVESTIGATION REPORT
C-4016 NEW ALLIED SCIENCE BUILDING
CONTRA COSTA COLLEGE
2600 MISSION BELL DRIVE
SAN PABLO, CALIFORNIA
KLEINFELDER PROJECT No.: 20181569.001A**

**SUBJECT: Geotechnical Engineering Investigation Report
C-4016 New Allied Science Building
Contra Costa College
2600 Mission Bell Drive
San Pablo, California**

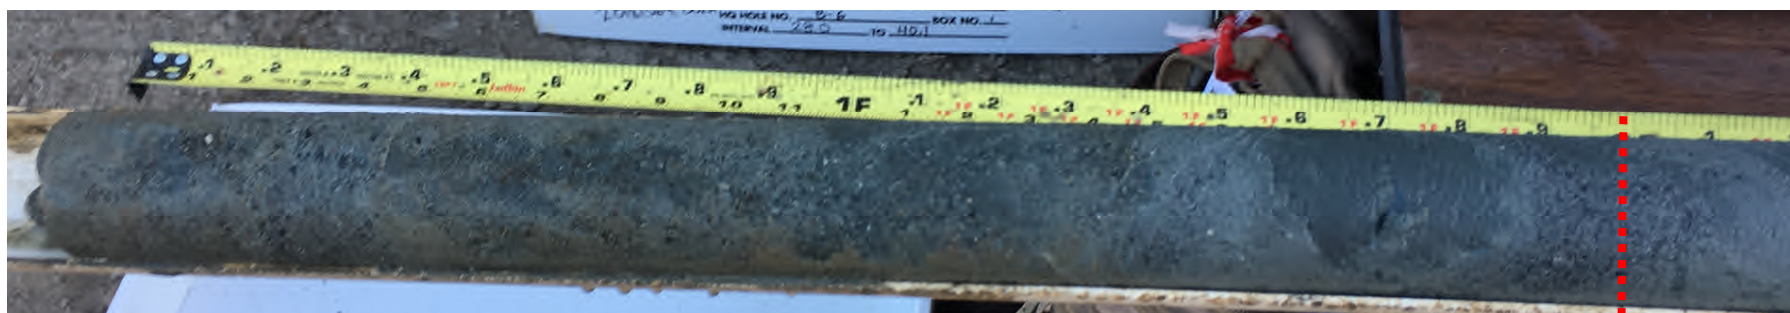
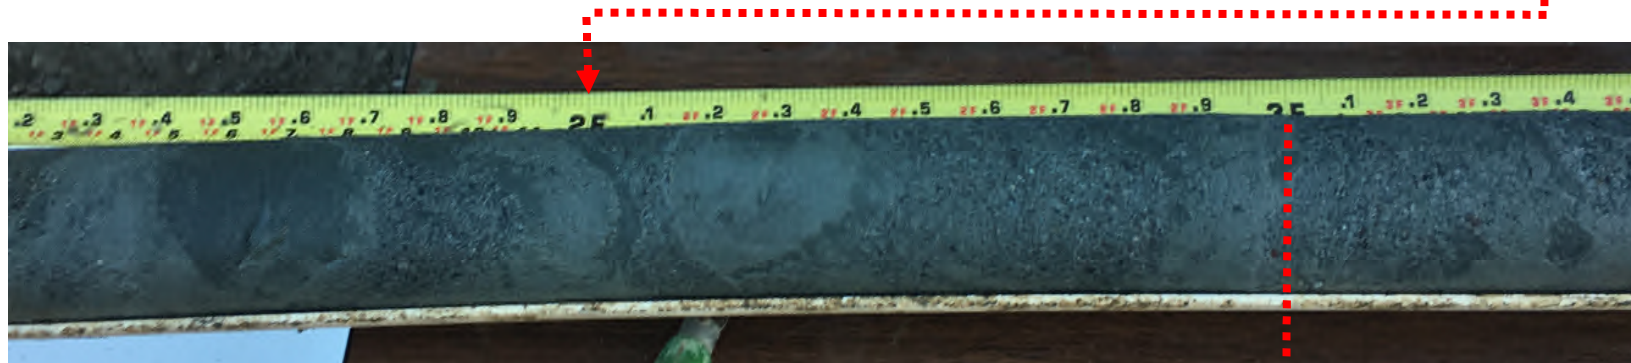
BORING B-6 ROCK CORE
RUN 6 — 46.0—51.0 FT

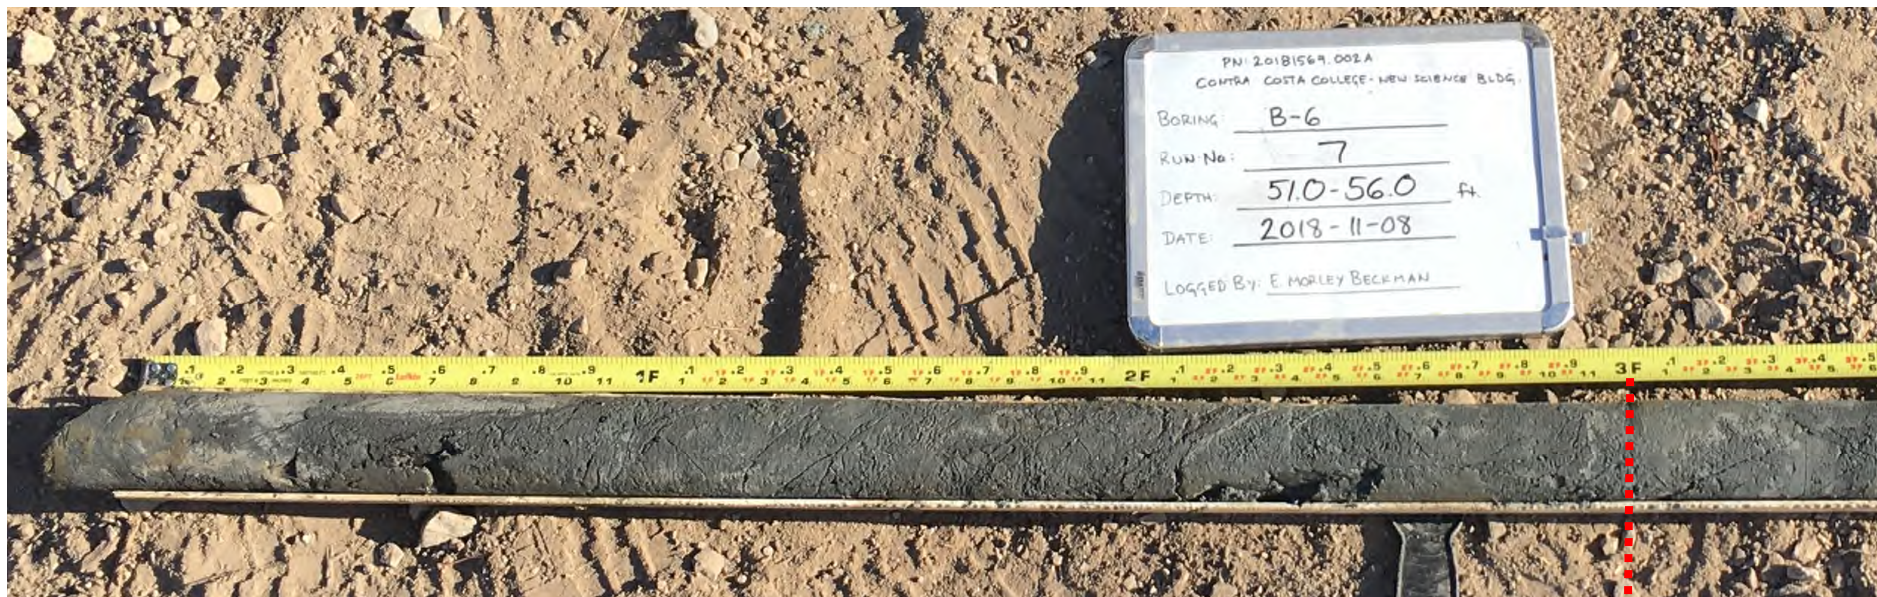
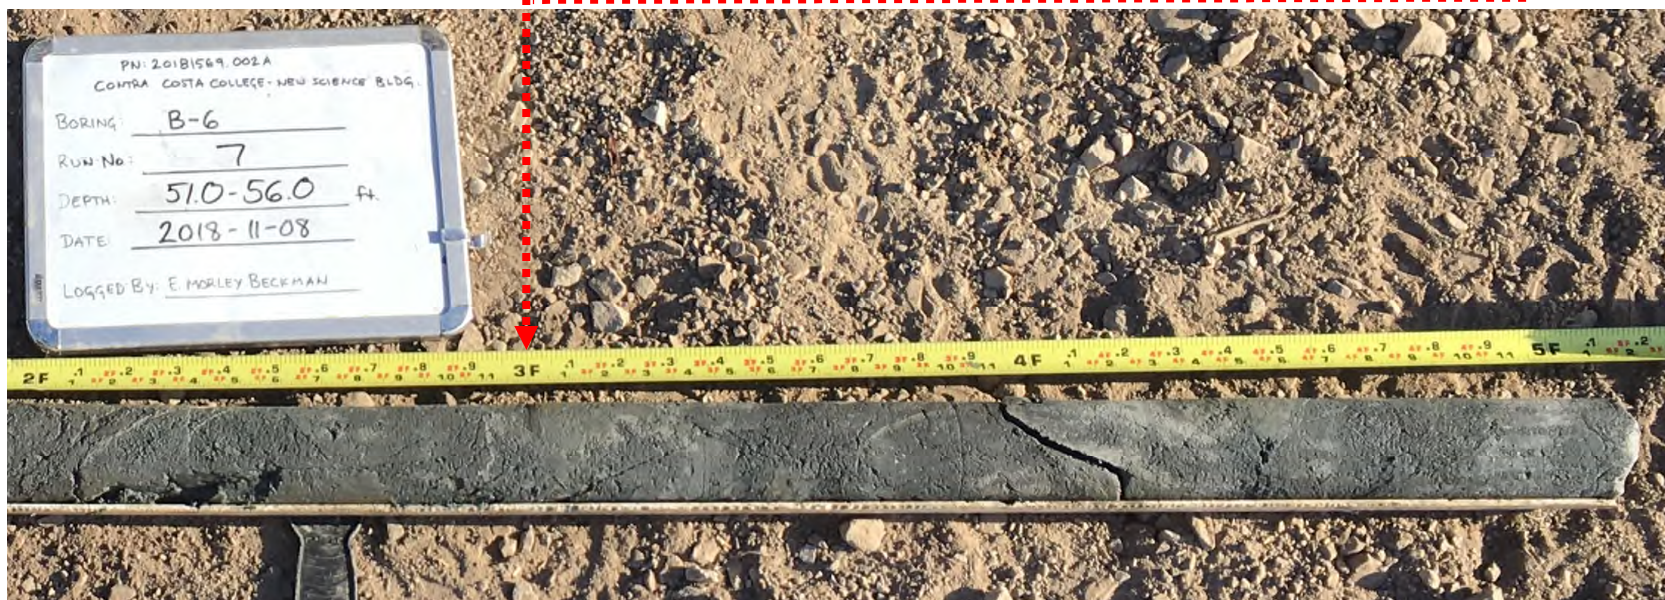
B-7

BORING B-6 ROCK CORE
RUN 7 — 51.0—56.0 FT

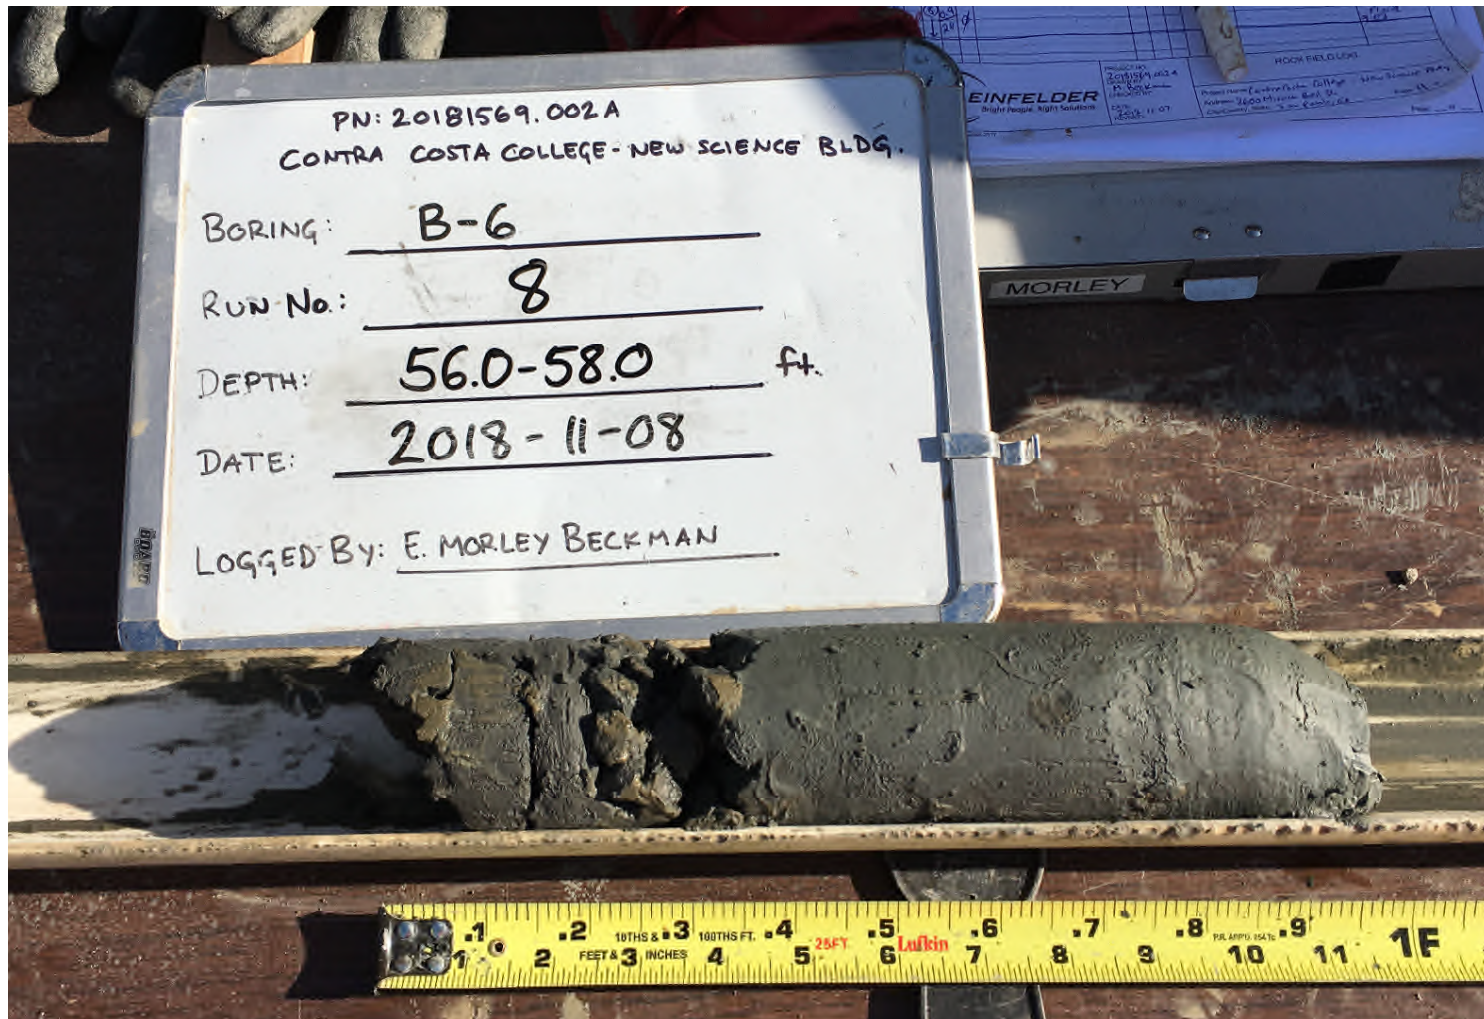
B-8

BORING B-6 ROCK CORE
RUN 8 — 56.0—58.0 FT

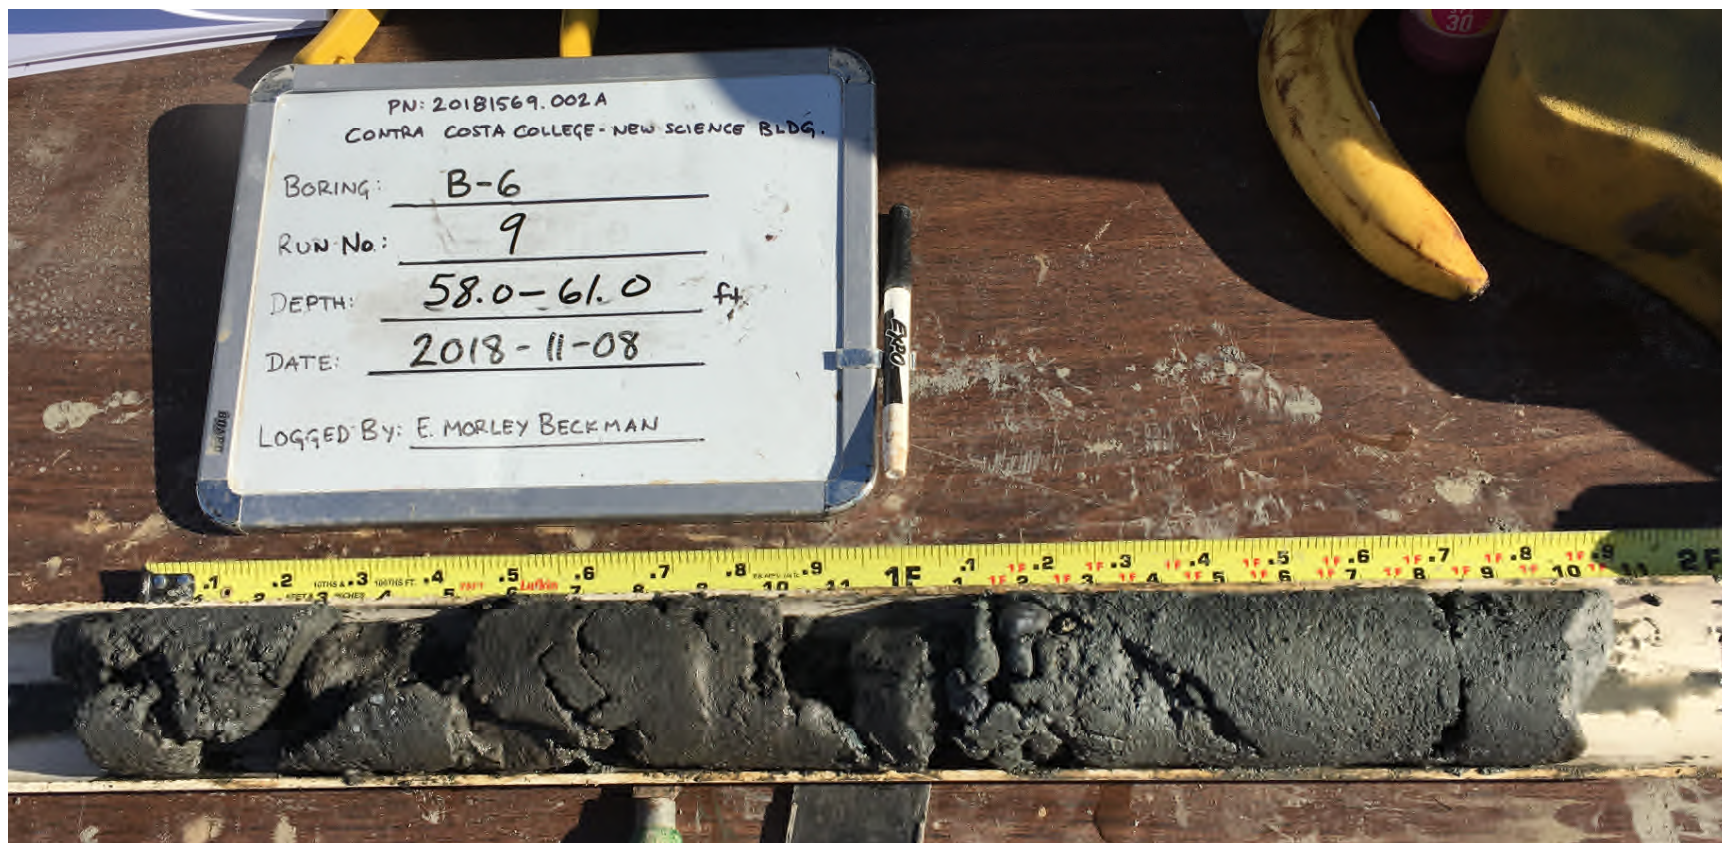
B-9

BORING B-6 ROCK CORE
RUN 9 — 58.0—61.0 FT

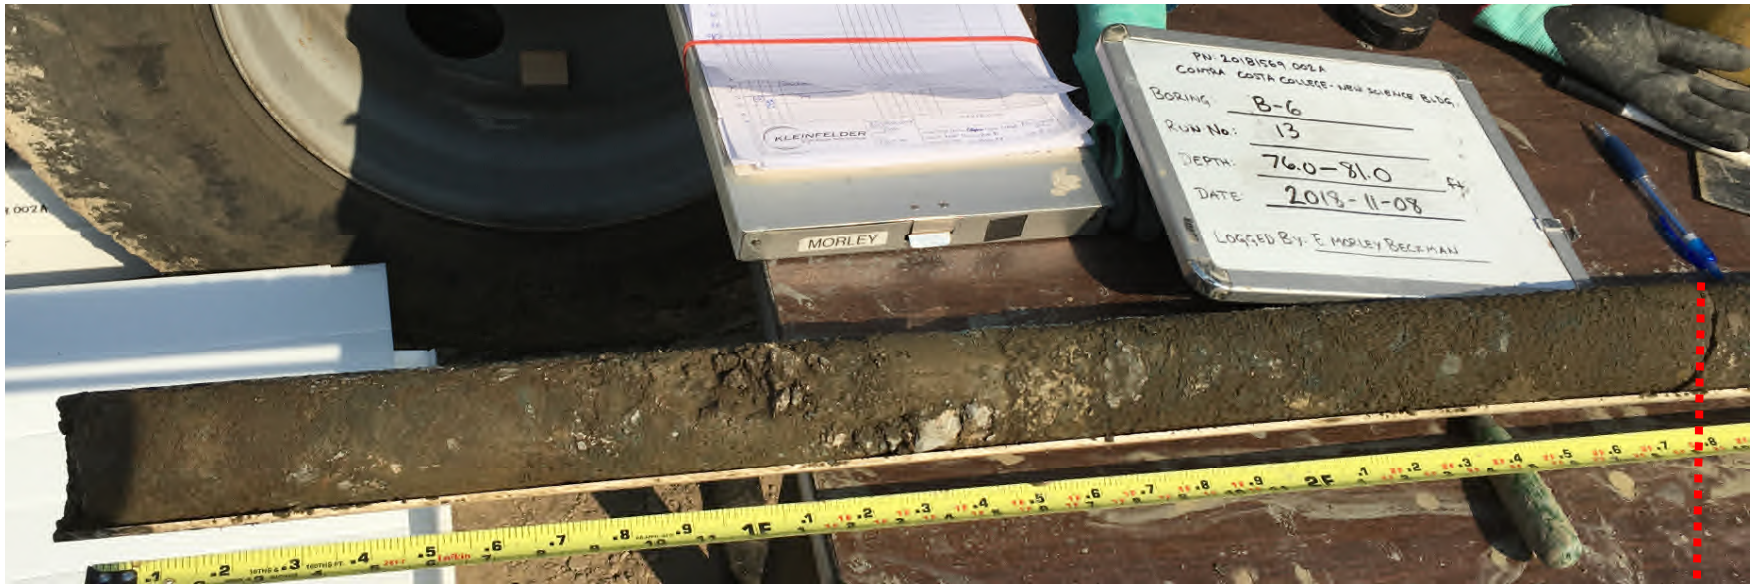
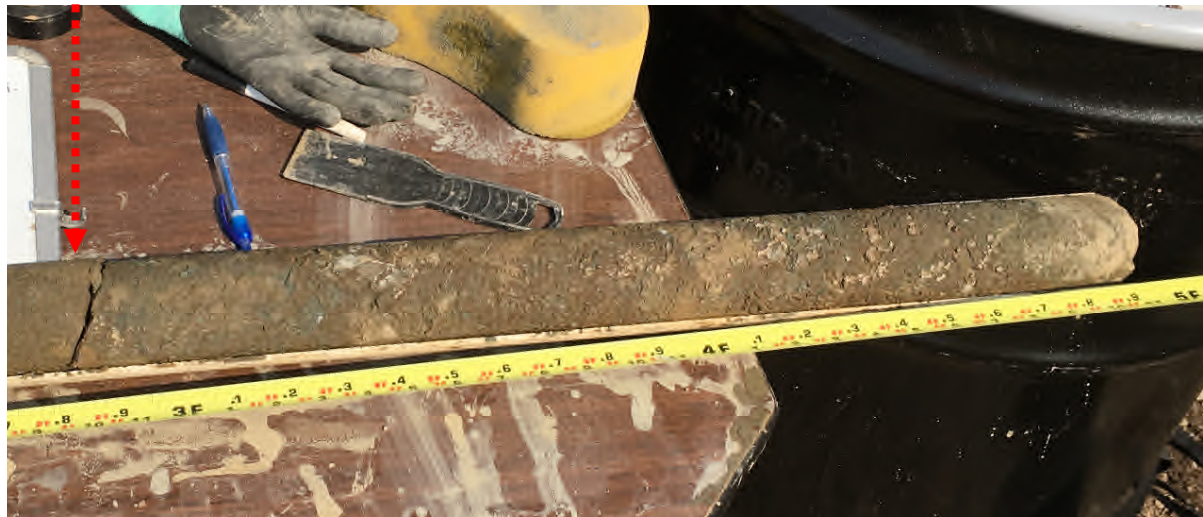
B-13

BORING B-6 ROCK CORE
RUN 13 — 76.0—81.0 FT

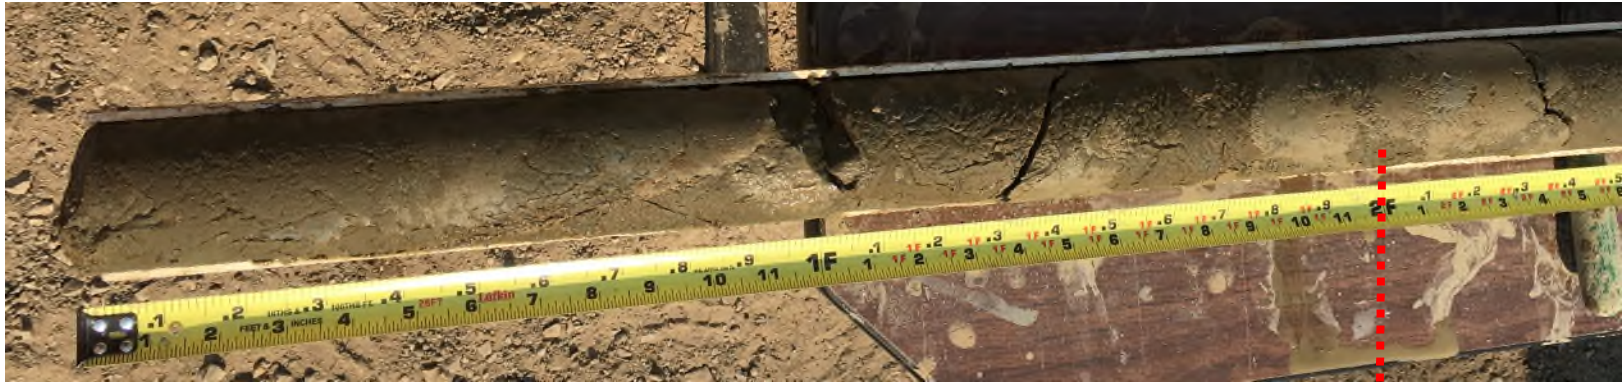
B-15

BORING B-6 ROCK CORE
RUN 15 — 86.0—91.0 FT

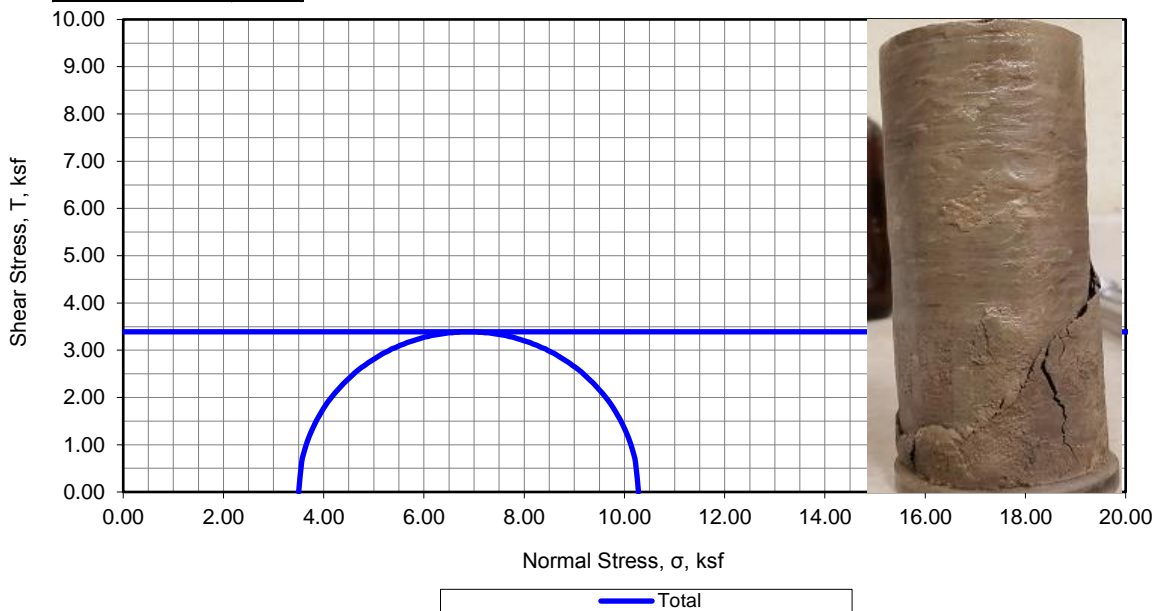
Total	
c =	3.39 ksf

Specimen No.		1
Initial	Diameter, in	D ₀ 2.29
	Height, in	H ₀ 5.00
	Water Content, %	ω ₀ 10.9
	Dry Density, lbs/ft ³	γ _{d0} 125.7
	Saturation, %	S ₀ 91
	Void Ratio	e ₀ 0.315
Minor Principal Stress, ksf		σ ₃ 3.50
Maximum Deviator Stress, ksf		(σ ₁ -σ ₃) _{max} 6.78
Time to (σ ₁ -σ ₃) _{max} , min		t _f 2.03
Deviator Stress @ 15% Axial Strain, ksf		(σ ₁ -σ ₃) _{15%} 5.39
Ultimate Deviator Stress, ksf		(σ ₁ -σ ₃) _{ult} na
Rate of strain, %/min		'ε 1.00
Axial Strain at Failure, %		ε _f 2.03

Description of Specimen: Brown Lean Clay with Sand (CL)
