**GEOTECHNICAL ENGINEERING  
INVESTIGATION REPORT  
C-4016 NEW ALLIED SCIENCE BUILDING  
CONTRA COSTA COLLEGE  
2600 MISSION BELL DRIVE  
SAN PABLO, CALIFORNIA  
KLEINFELDER PROJECT No.: 20181569.001A**

**SUBJECT: Geotechnical Engineering Investigation Report  
C-4016 New Allied Science Building  
Contra Costa College  
2600 Mission Bell Drive  
San Pablo, California**

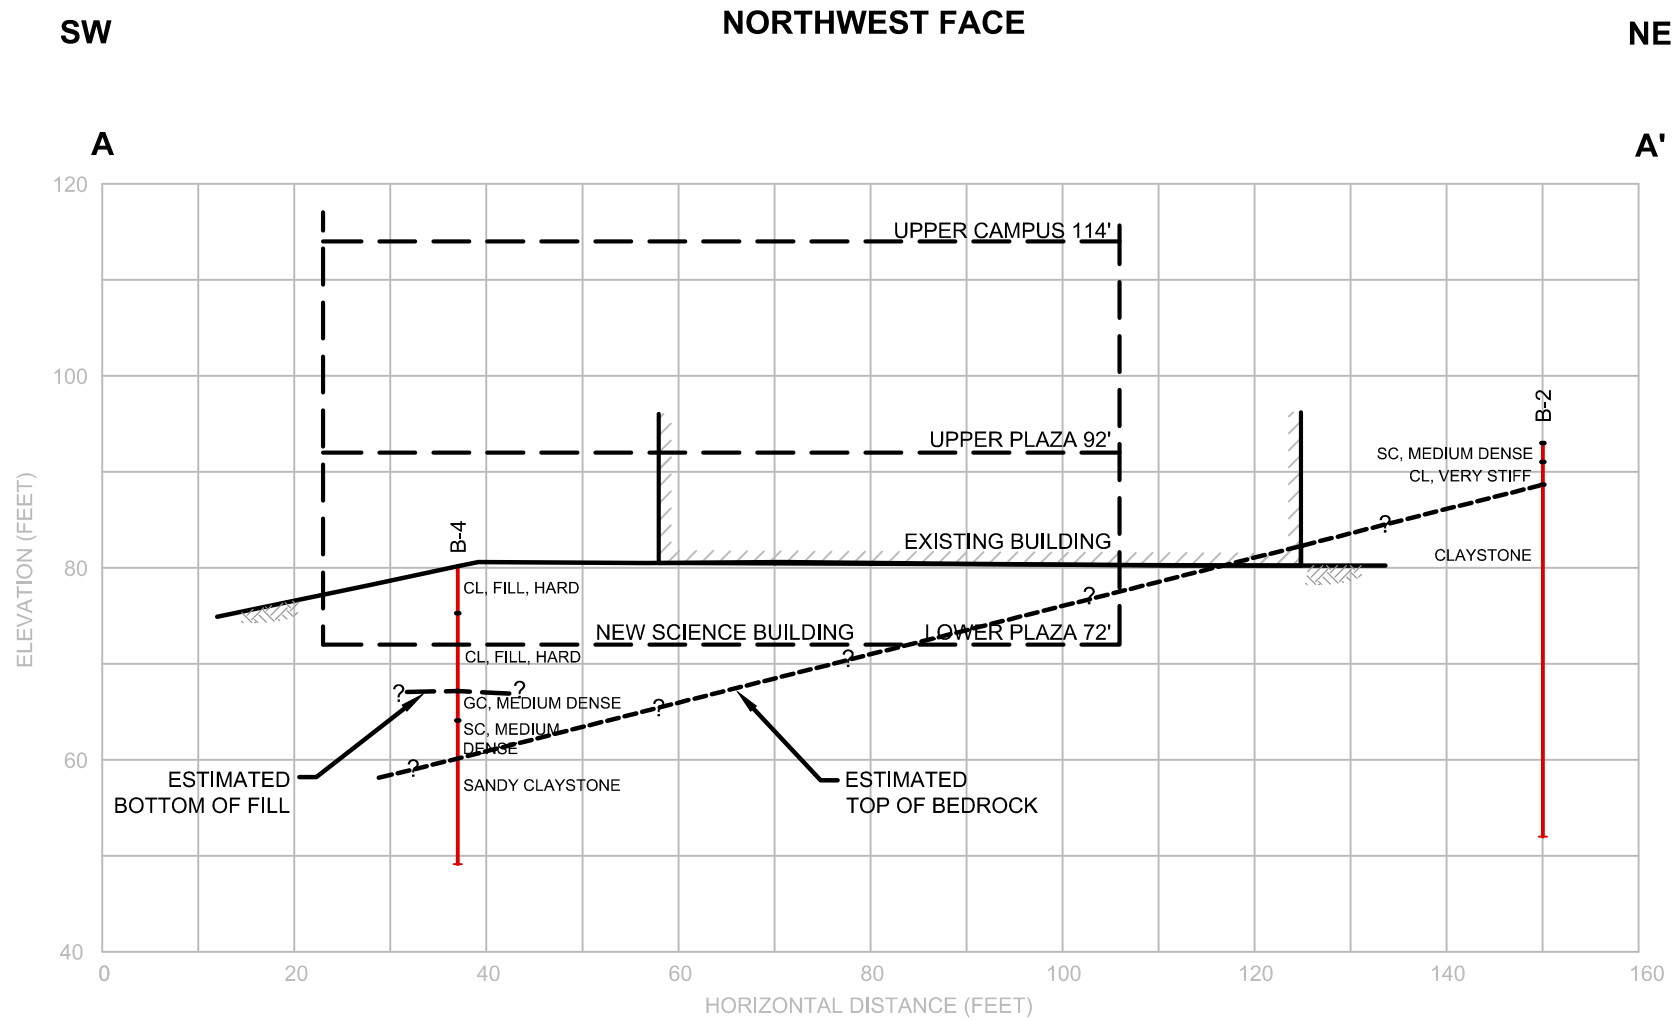
PLATE  
3

1. SEE FIGURE 2 FOR LOCATION OF CROSS SECTION.
2. " BOTTOM OF FILL LINE" AND "TOP OF BEDROCK LINE" ARE ROUGH ESTIMATED INTERFACE LINES BASED ON LIMITED SUBSURFACE INFORMATION. THE ACTUAL SUBSURFACE CONDITIONS COULD BE SIGNIFICANTLY DIFFERENT FROM THOSE SHOWN ABOVE DUE TO PAST GRADING AND CONSTRUCTION AT THE SITE.

CROSS SECTION A-A'  
CONTRA COSTA COMMUNITY COLLEGE  
NEW SCIENCE BUILDING  
2600 MISSION BELL DRIVE  
SAN PABLO, CALIFORNIA

- SOIL BORING  
 (By Kleinfelder, 2017)
- CROSS SECTION LINE  
 (See Figures 3 & 4 for cross  
 section view)

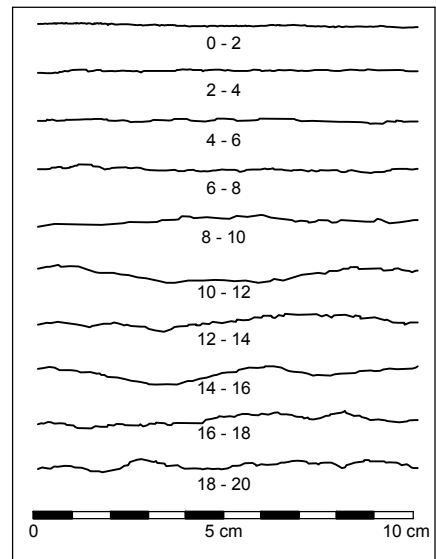
**JOINT ROUGHNESS COEFFICIENT (JRC)**

From Barton and Choubey, 1977

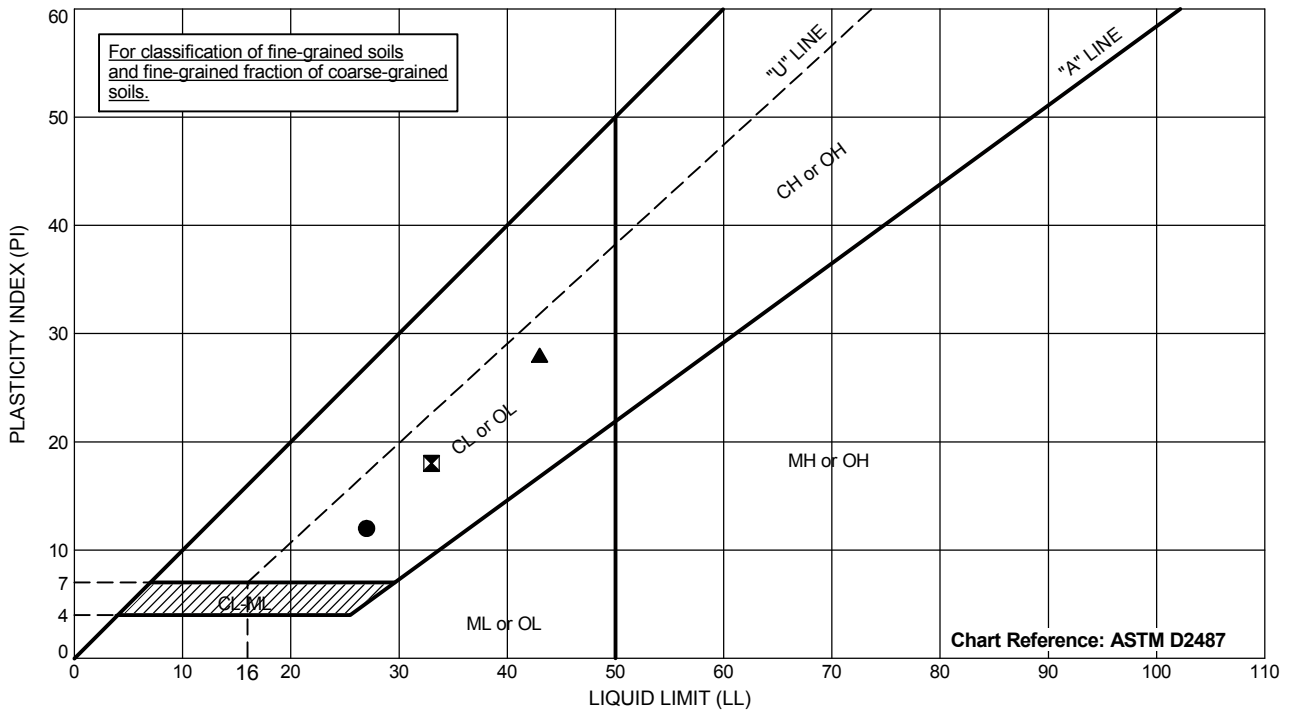
B-2

Exploration ID	Depth (ft.)	Sample Description	Passing #200	LL	PL	PI
● B-3	2.5	OLIVE BROWN CLAYEY SAND (SC)	NM	27	15	12
■ B-3	16	OLIVE BROWN CLAYEY SAND (SC)	49	33	15	18
▲ B-4	6	OLIVE BROWN LEAN CLAY WITH SAND (CL)	NM	43	15	28

Testing performed in general accordance with ASTM D4318.  
 NP = Nonplastic  
 NM = Not Measured

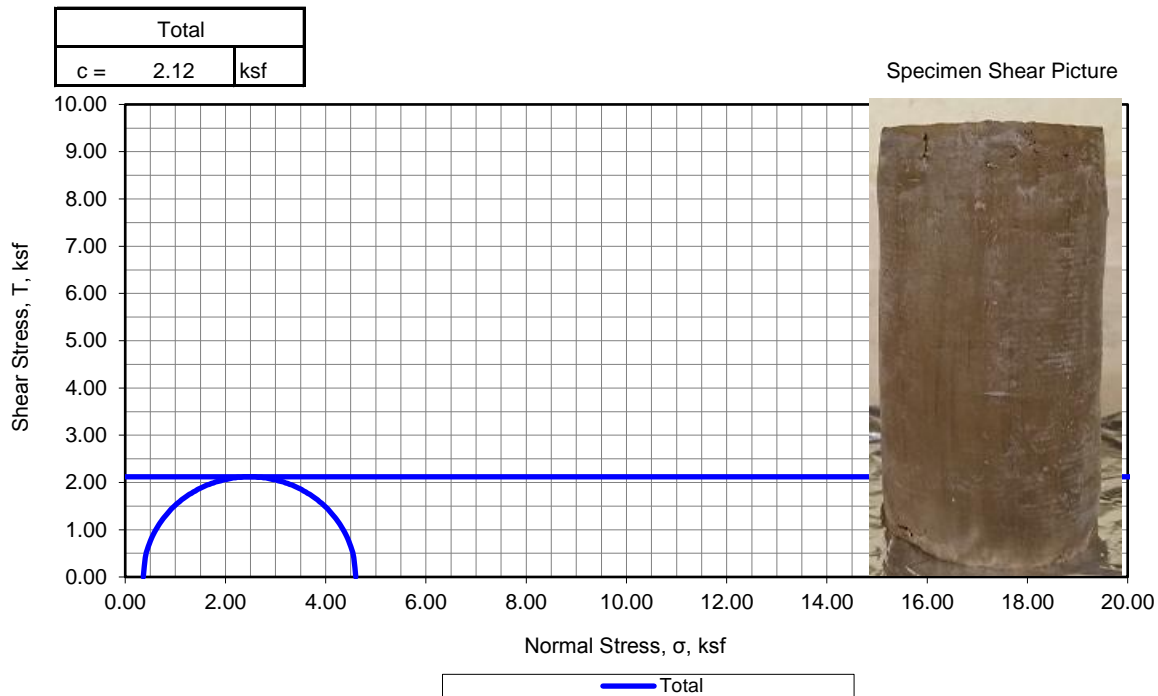
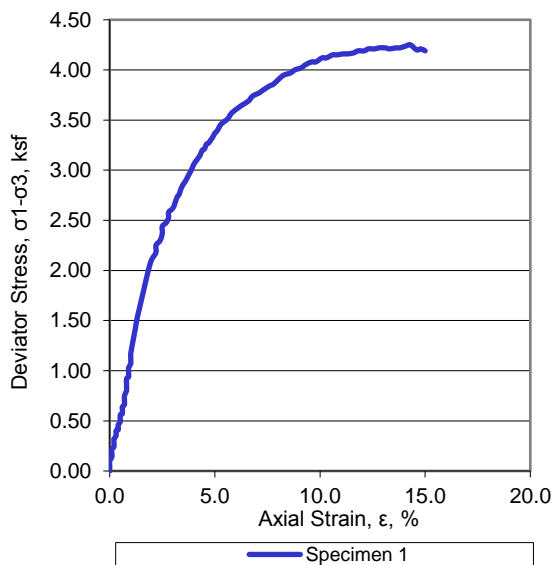
Specimen No.		1
Initial	Diameter, in	$D_o$ 2.39
	Height, in	$H_o$ 5.69
	Water Content, %	$\omega_o$ 19.1
	Dry Density, lbs/ft <sup>3</sup>	$\gamma_{d_o}$ 108.8
	Saturation, %	$S_o$ 97
	Void Ratio	$e_o$ 0.519
Minor Principal Stress, ksf		$\sigma_3$ 0.36
Maximum Deviator Stress, ksf		$(\sigma_1 - \sigma_3)_{max}$ 4.25
Time to $(\sigma_1 - \sigma_3)_{max}$ , min		$t_f$ 14.33
Deviator Stress @ 15% Axial Strain, ksf		$(\sigma_1 - \sigma_3)_{15\%}$ 4.19
Ultimate Deviator Stress, ksf		$(\sigma_1 - \sigma_3)_{ult}$ na
Rate of strain, %/min		$\dot{\epsilon}$ 1.00
Axial Strain at Failure, %		$\epsilon_f$ 14.33

Description of Specimen: Olive Brown Sandy Lean Clay (CL)

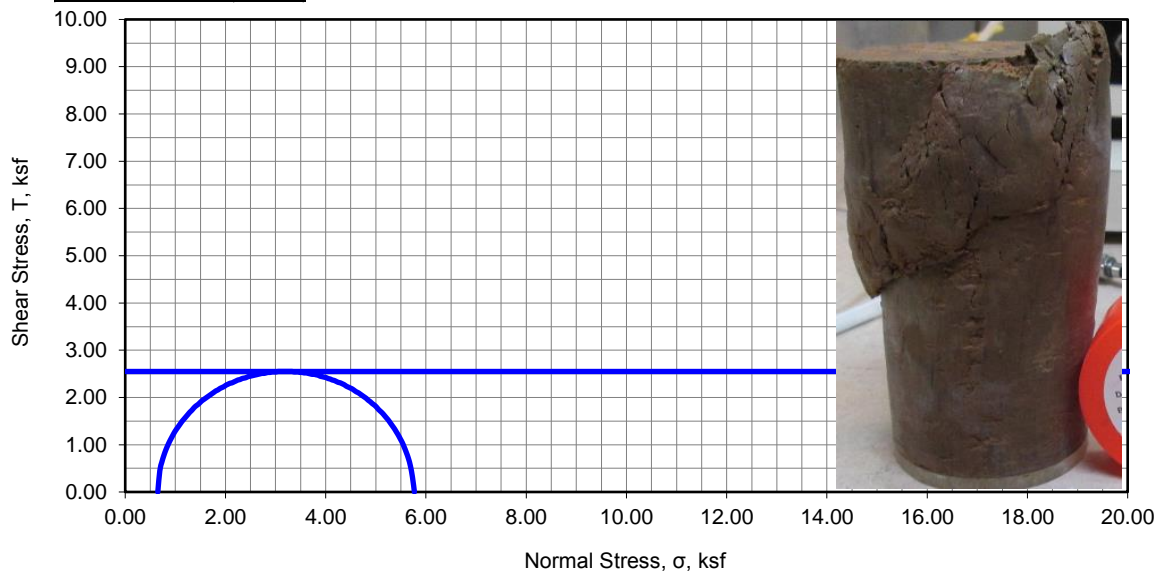
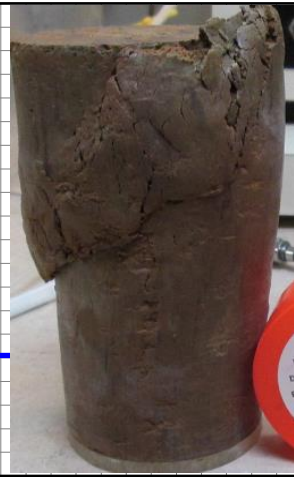
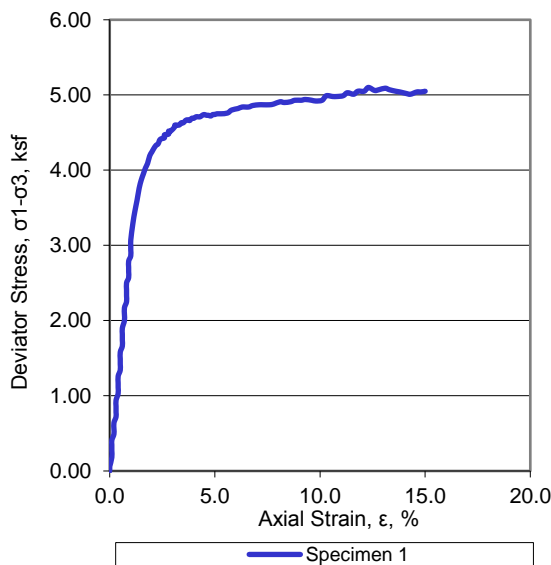
Specimen Shear Picture

Specimen No.		1
Initial	Diameter, in	D <sub>0</sub> 2.43
	Height, in	H <sub>0</sub> 5.67
	Water Content, %	ω <sub>0</sub> 14.0
	Dry Density, lbs/ft <sup>3</sup>	γ <sub>d0</sub> 115.8
	Saturation, %	S <sub>0</sub> 87
	Void Ratio	e <sub>0</sub> 0.428
Minor Principal Stress, ksf		σ <sub>3</sub> 0.65
Maximum Deviator Stress, ksf		(σ <sub>1</sub> -σ <sub>3</sub> ) <sub>max</sub> 5.10
Time to (σ <sub>1</sub> -σ <sub>3</sub> ) <sub>max</sub> , min		t <sub>f</sub> 12.33
Deviator Stress @ 15% Axial Strain, ksf		(σ <sub>1</sub> -σ <sub>3</sub> ) <sub>15%</sub> 5.05
Ultimate Deviator Stress, ksf		(σ <sub>1</sub> -σ <sub>3</sub> ) <sub>ult</sub> na
Rate of strain, %/min		'ε 1.00
Axial Strain at Failure, %		ε <sub>f</sub> 12.33

Description of Specimen: Brown Lean Clay with Sand (CL)

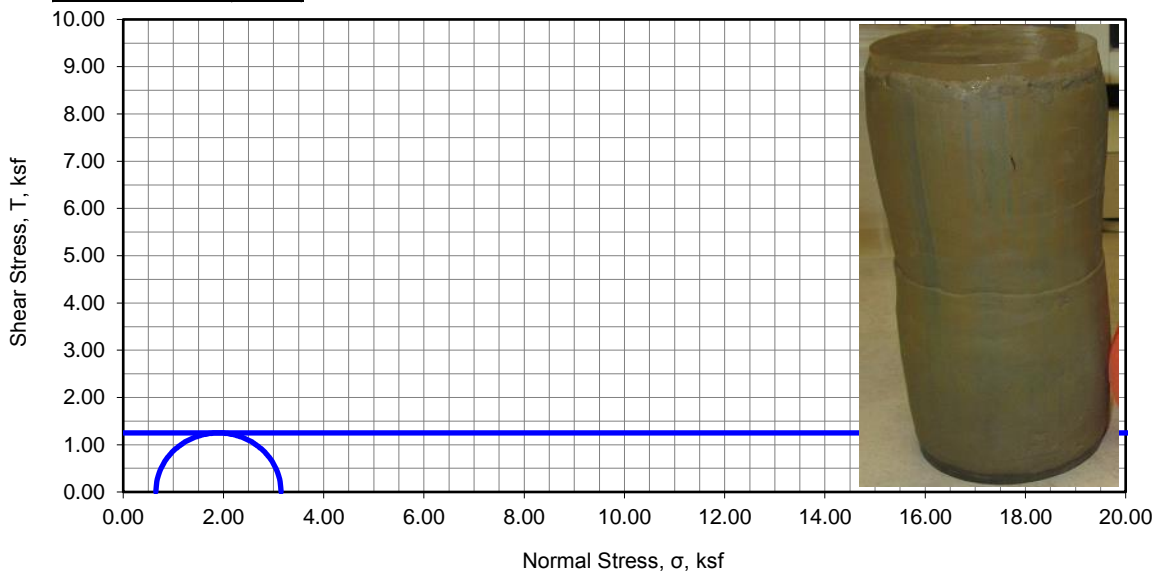
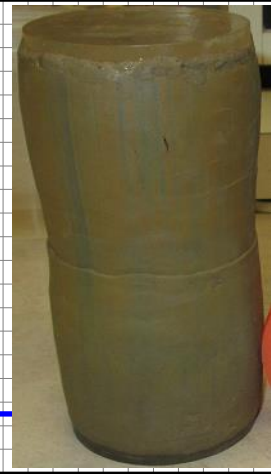
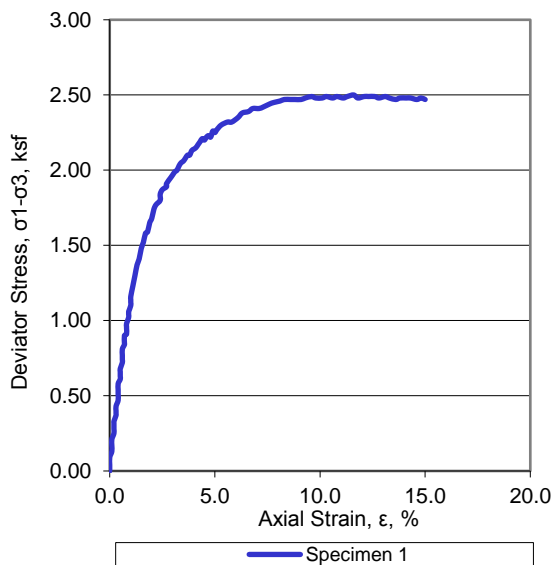
B-4

Total		
c =	1.25	ksf

Specimen No.		1
Initial	Diameter, in	$D_o$ 2.43
	Height, in	$H_o$ 5.70
	Water Content, %	$w_o$ 26.8
	Dry Density, lbs/ft <sup>3</sup>	$\gamma_{d_o}$ 94.7
	Saturation, %	$S_o$ 95
	Void Ratio	$e_o$ 0.747
Minor Principal Stress, ksf		$\sigma_3$ 0.65
Maximum Deviator Stress, ksf		$(\sigma_1 - \sigma_3)_{max}$ 2.50
Time to $(\sigma_1 - \sigma_3)_{max}$ , min		$t_f$ 11.58
Deviator Stress @ 15% Axial Strain, ksf		$(\sigma_1 - \sigma_3)_{15\%}$ 2.47
Ultimate Deviator Stress, ksf		$(\sigma_1 - \sigma_3)_{ult}$ na
Rate of strain, %/min		$\dot{\epsilon}$ 1.00
Axial Strain at Failure, %		$\epsilon_f$ 11.58

Description of Specimen: Brown Lean Clay (CL)
