Re: D-1150 Roof Replacement Life Health Science (LHS)
Pre-Renovation Asbestos Roof Survey
Diablo Valley College – Life and Health Science
321 Golf Club Road, Pleasant Hill, CA
Terracon Project No. R1247271

Asbestos Survey

DVC – Life and Health Science | Pleasant Hill, California

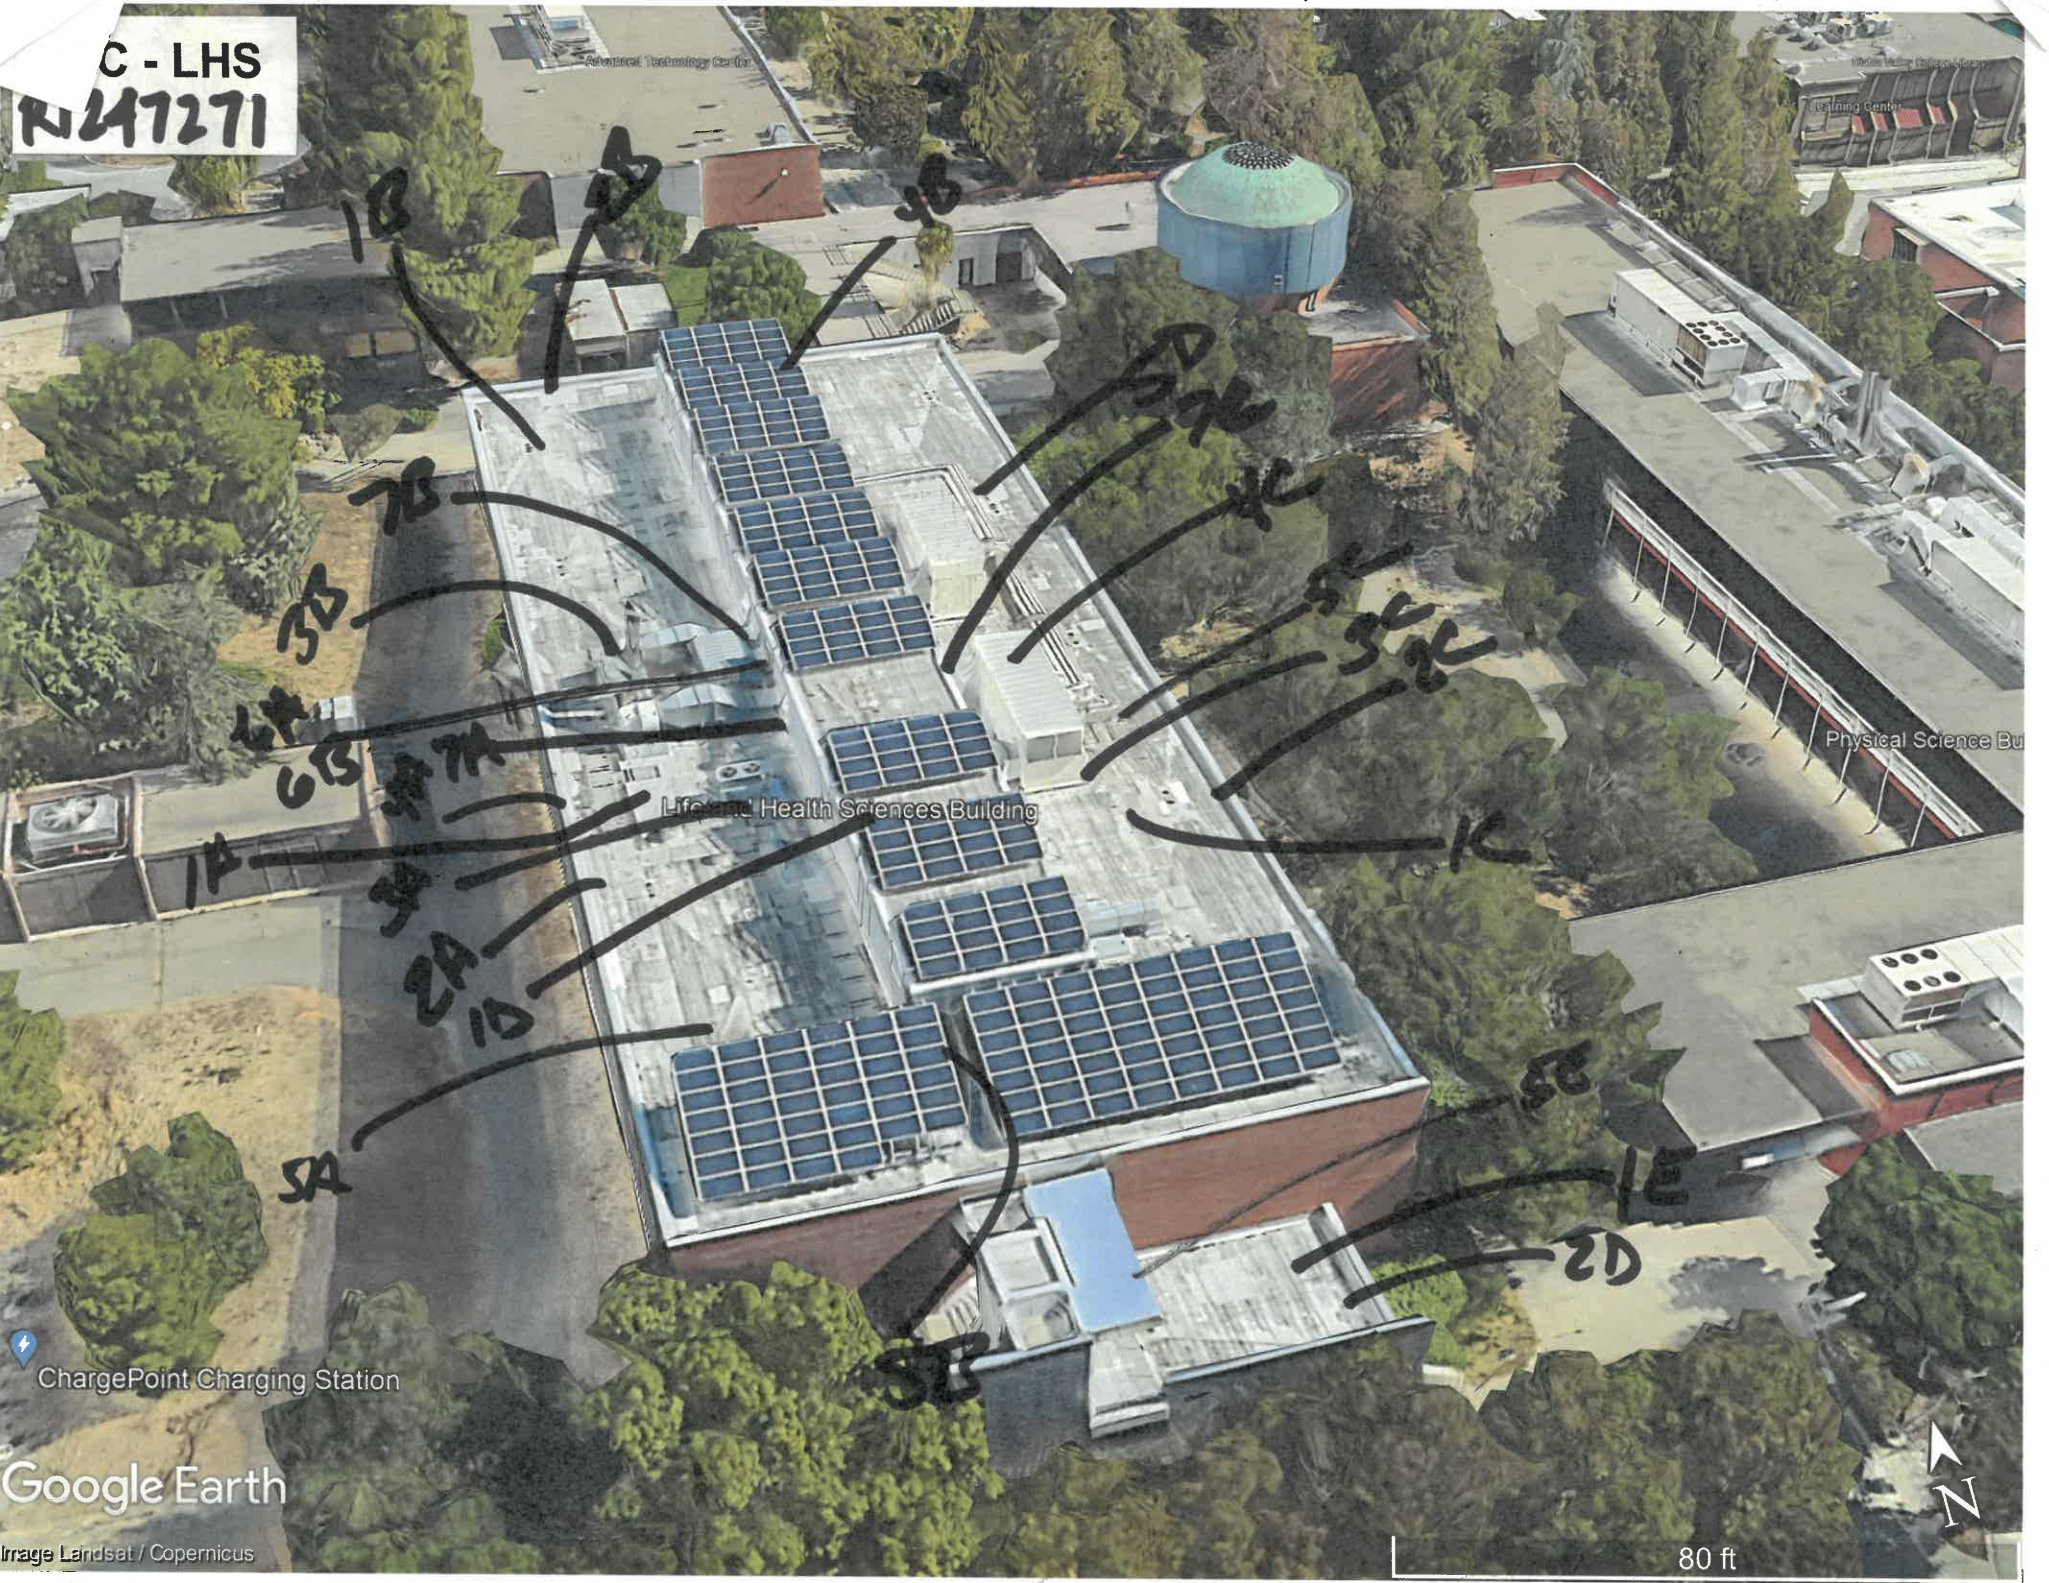
C - LHS
R47271

80 ft

A copy of the laboratory analytical report and the associated chain of custody are attached to this report. Sample locations, material descriptions, and material locations, can be found in the chain of custody. A copy of the sample location field diagram is also attached to this report.
