RE: Limited Pre-Renovation Asbestos and Lead Survey Report
Diablo Valley College – Renovations
321 Golf Club Road, Pleasant Hill, CA
Terracon Project #: R1227200

Terracon Consultants, Inc. (Terracon) conducted limited pre-renovation asbestos and lead surveys of the following buildings on the Diablo Valley College (DVC) campus located at 321 Golf Club Road, Pleasant Hill, California, on March 18 and 21, 2022.

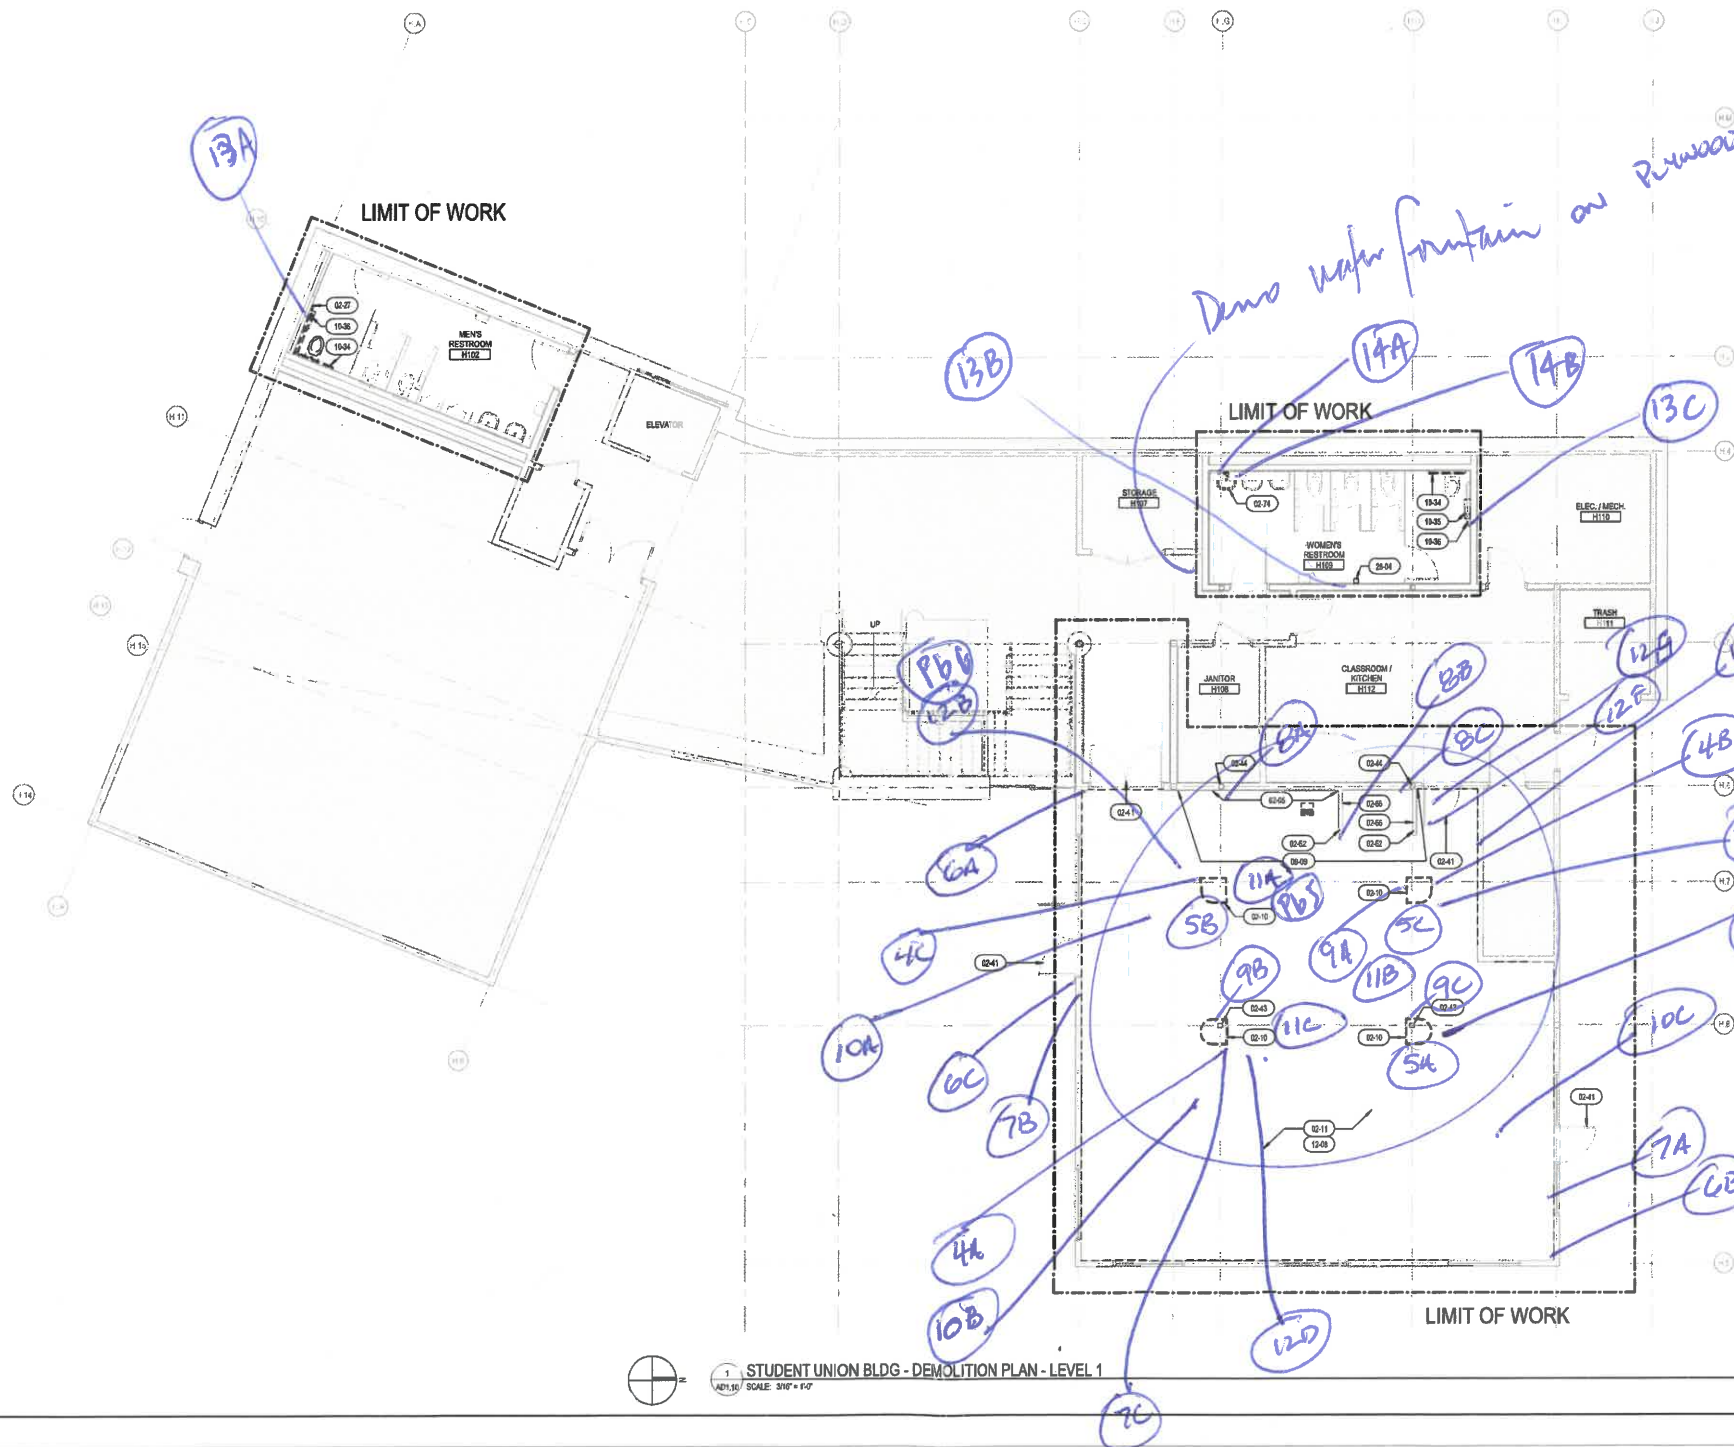
AD1.20

| 02-13 | REMOVE EXISTING WALL, FRAMING AND BRISSES TO

REPLACE WITH NEW DOOR FRAME
REMOVE EXISTING COUNTERS, BELOW COUNTER
CASCADING, UPPER COUNTERS AND WAIN WALLS
REMOVE EXISTING COUNTERS AND SINKS AND
ASSOCIATED STORAGE UNITS |

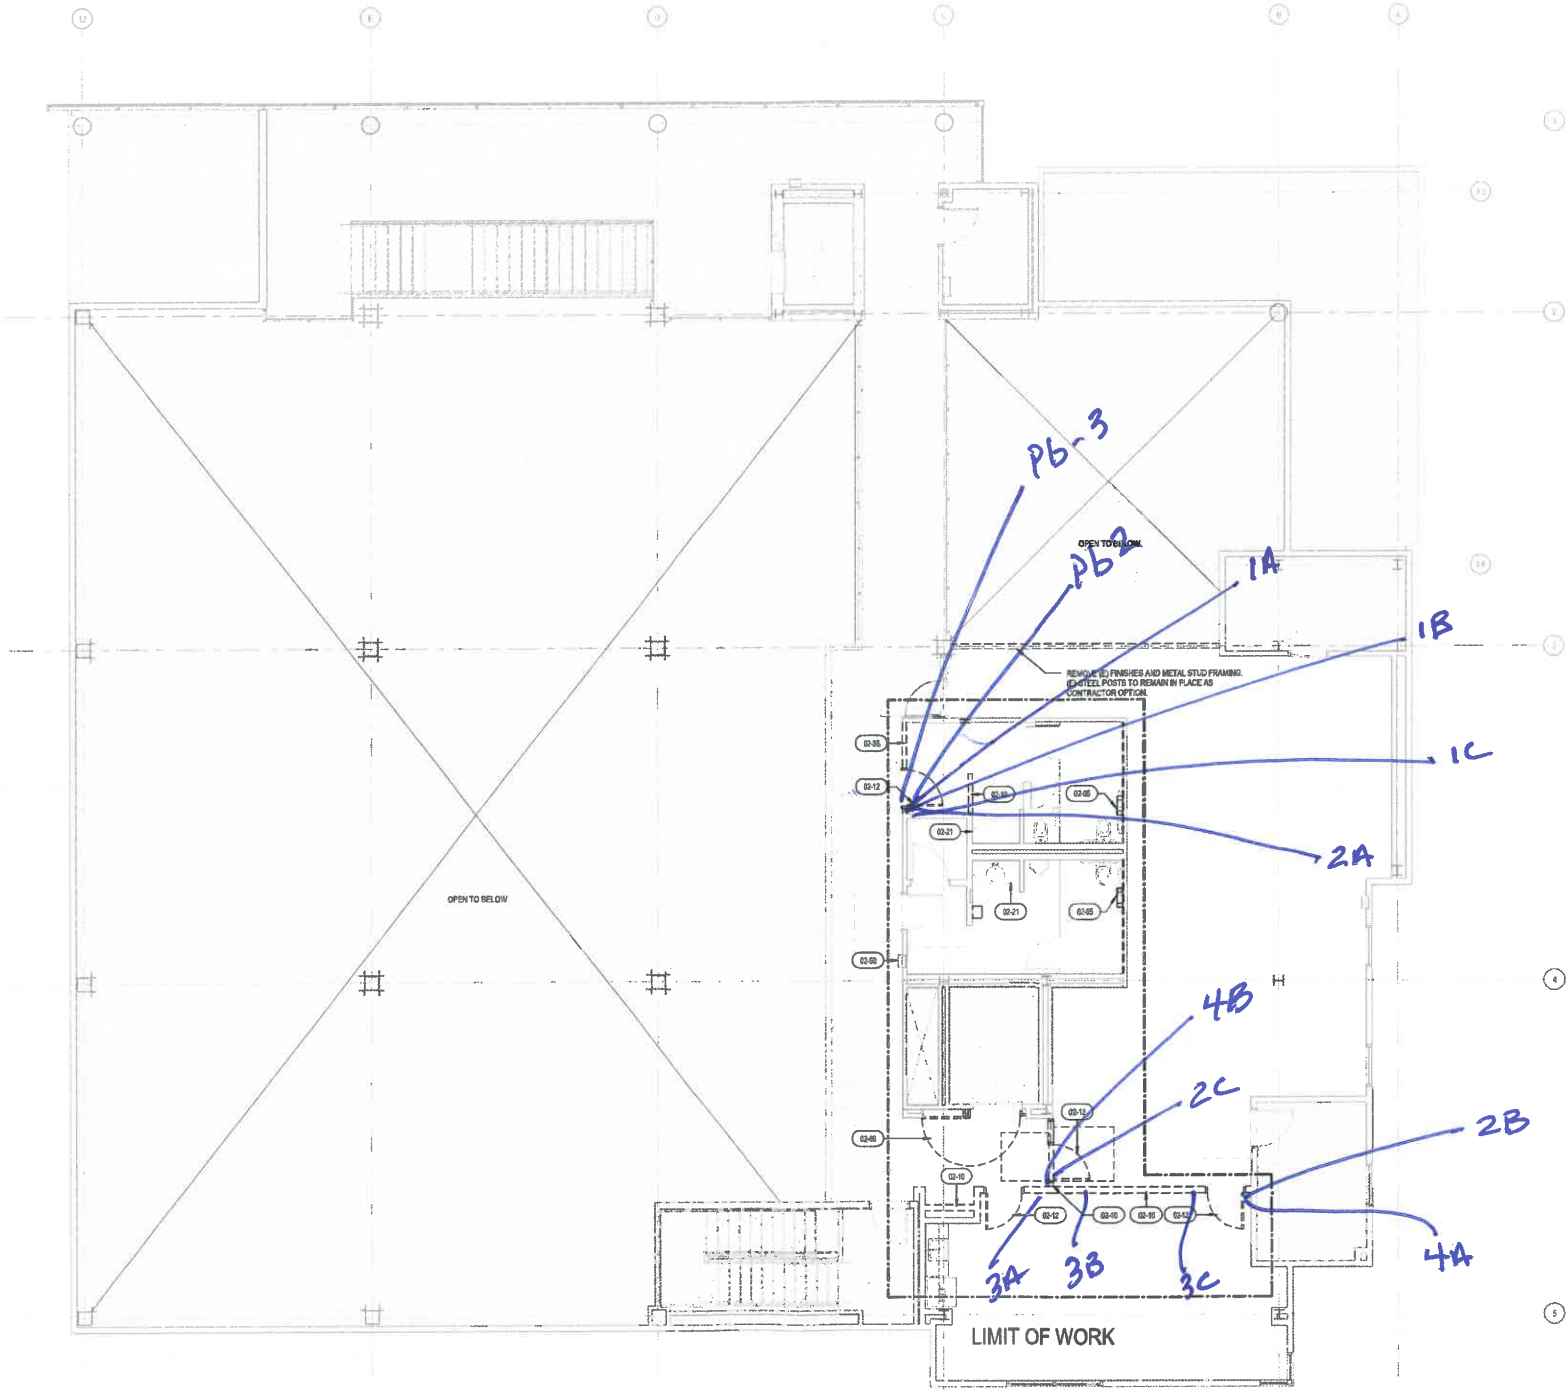
AD2.31

PRINT SHOP - BOOKSTORE -
LEVEL 2 - DEMOLITION PLAN
